Investigation report

Internal accident investigation

Well Control Incident Troll Q-21

Classification:	Internal	Status:	Final
Report no.:	N/A	Date:	02.03.2026
Expiration date:	N/A	Synergi no.:	6445754

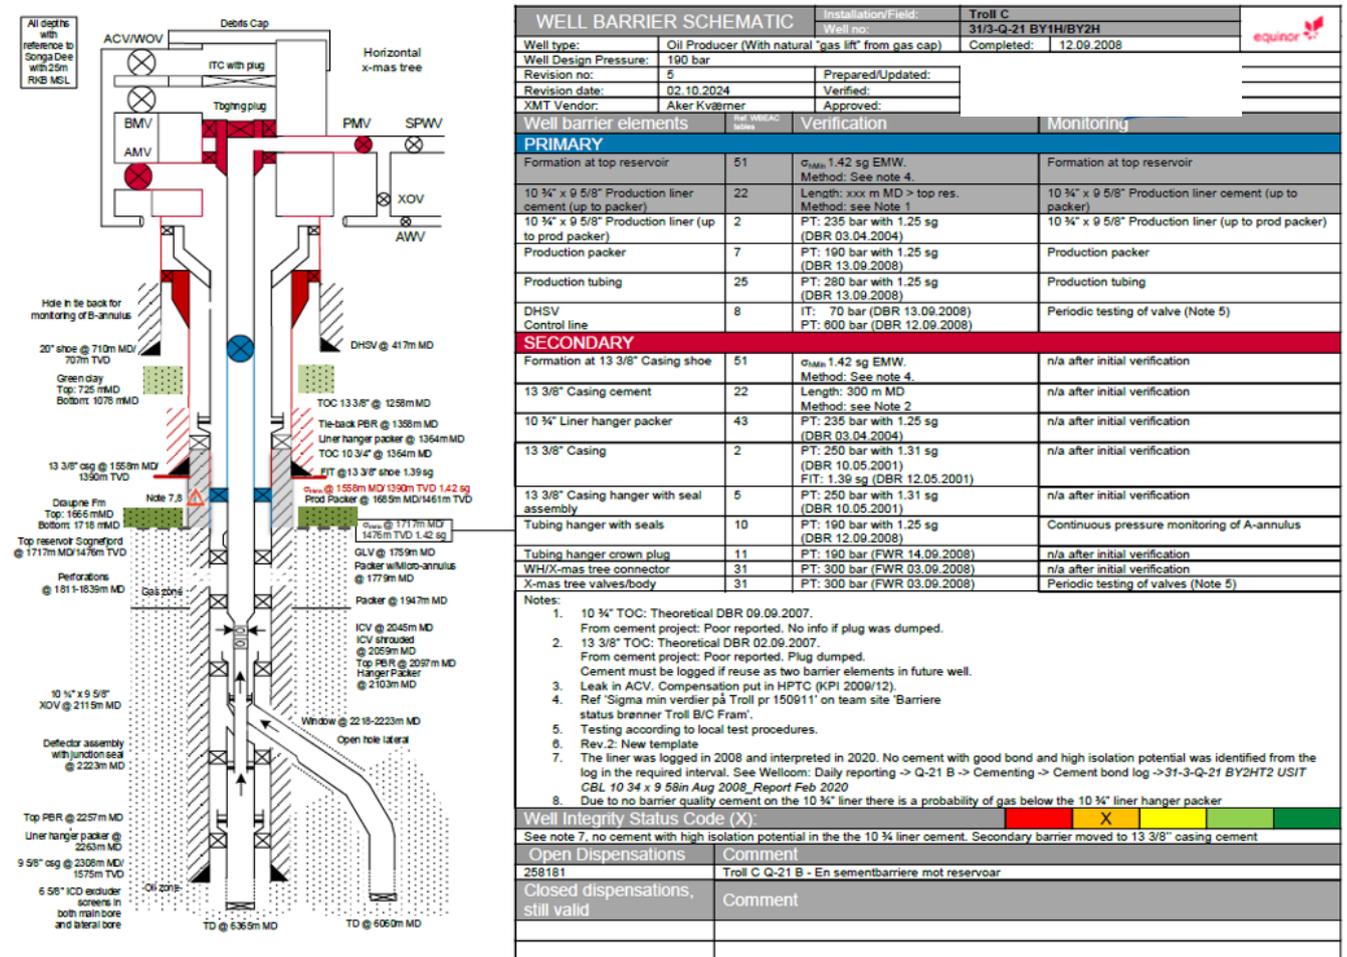
Figure 4-3: Barrier status prior to pre-P&A work in 2025 (Schematic from 2008)

Well Q-21 was given an orange barrier status in 2020 based on: "no cement with high isolation potential in the 10 3/4" liner cement. Secondary barrier moved to 13 3/8" casing cement", as shown in Figure 4-3. The cement job on the 13 3/8" casing in the B-bore was done in 2007 but not logged. When casing cement is used as a common well barrier, i.e. representing primary and secondary barrier elements, it is required to perform a cement bond log and prove that there is a minimum of 2 x 30 m cemented interval with sufficient hydraulic bonding, where 30 m is the barrier length requirement for single well barrier element. The vertical position of the barriers shall be such that the uppermost barrier section (upper 30 m) is strong enough to sustain maximum anticipated pressure from below.

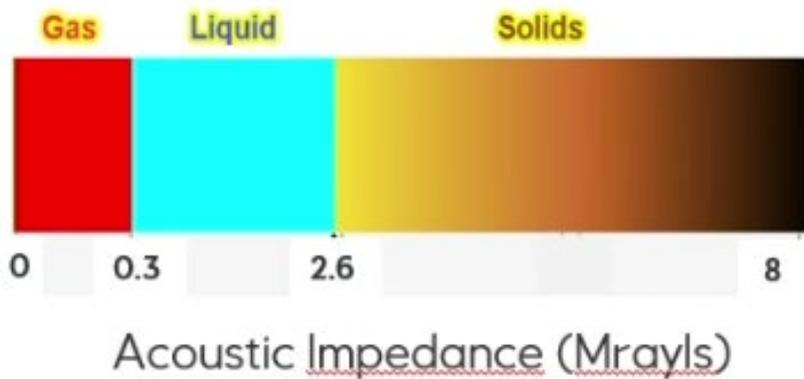
Figure 4-4: Acoustic Impedance value bands for varied materials

Turning C0 OFF caused a shift in the acoustic impedance.

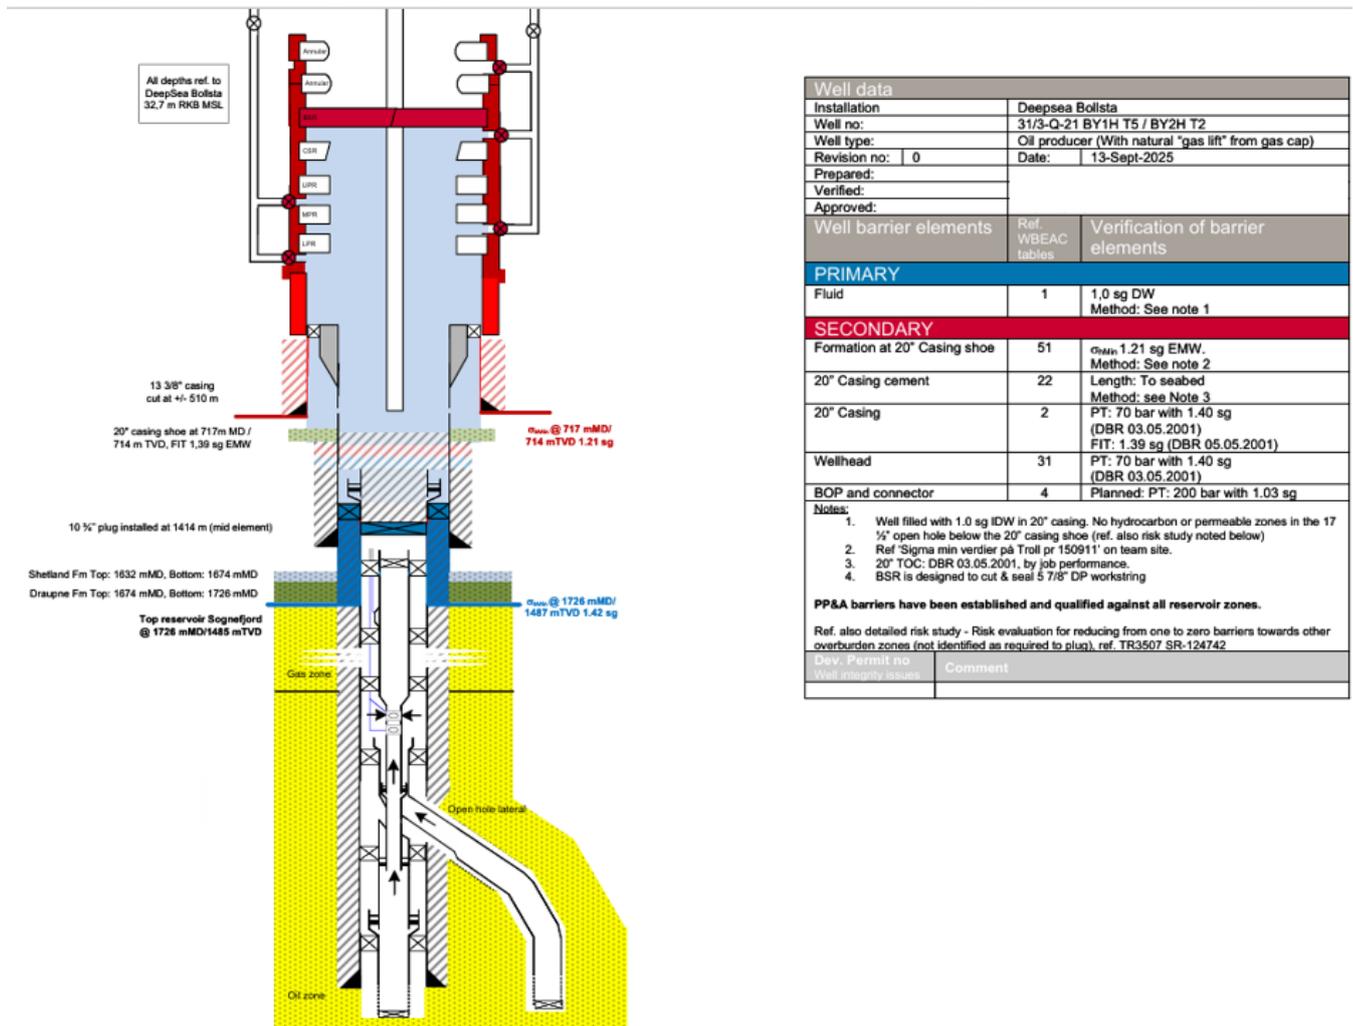
Figure 4-5: Well Barrier Status immediately prior to the commencement of casing cutting operations

At 03:57 in the morning 23rd September 2025⁸, the 13 3/8" casing was cut at 510 m and the well started to flow. Pumps were stopped, the crew on the drill floor excluded u-tubing as the cause of increased flow out and activated the BOP and diverter. Large amounts of water created overflow on the shakers, followed by mixture of water and gas. On drill floor a flow of water was observed from the rotary table followed by gas reaching above fingerboard level. HC Gas sensors activated ESD1 shutdown of all non-essential power sources according to design.

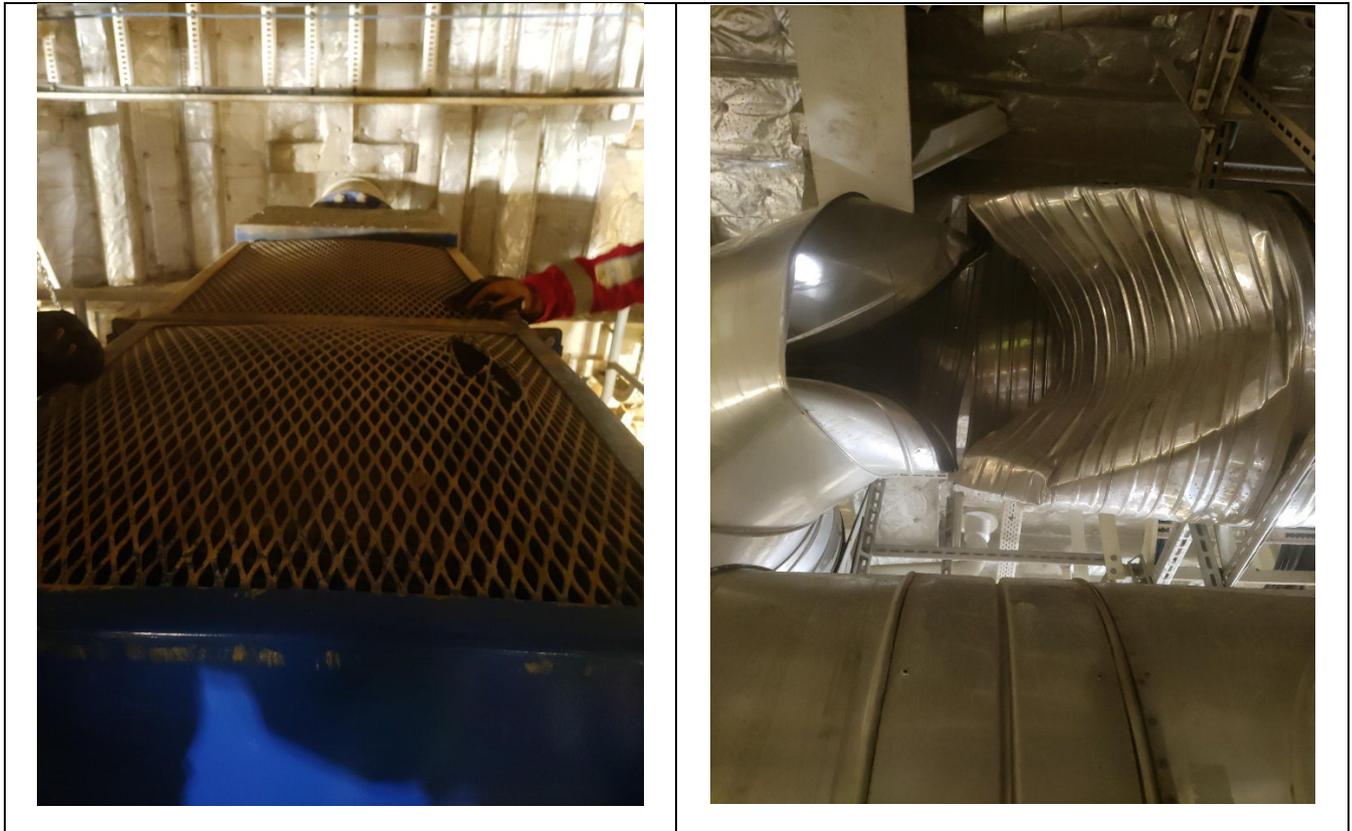
Figure 4-7: Gumbo box with damage in grating on top of it, and damages to HVAC ducts in the ceiling above the gumbo box

As gas expanded into the shale shaker room the pressure differential in the room has altered affecting the sealing elements around the doors. This pressure differential change was also experienced by the person escaping the room as making the doors more difficult to open.

Drill water was discharged from the gumbo box under pressure, resulting in damage to the ventilation ducts located under the ceiling over the gumbo box, see Figure 4-7.

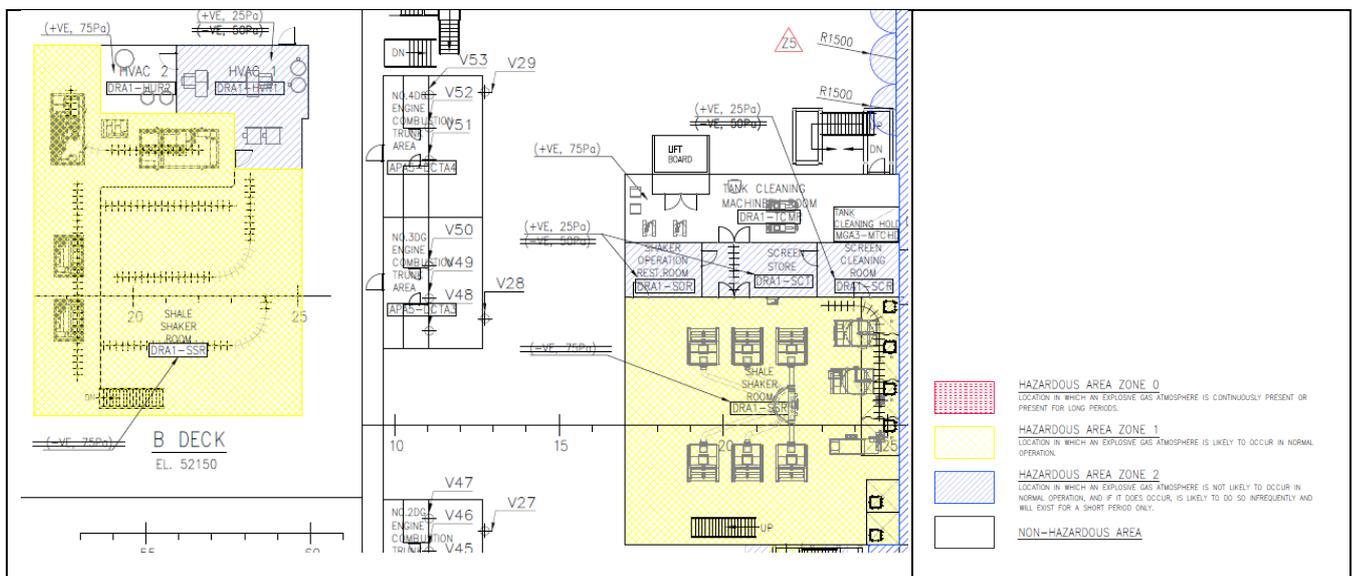
Figure 6-2: From 550-101-S-XE-001 Hazardous Area Plan A Deck Deepsea Bollsta

The sealing elements around the door leading to HVAC 2, which is classified as a Non-Hazardous Area, were also altered. There are no gas detectors in this room. It is not known to the investigation team whether this room was exposed to gas or whether there was ignition sources present. The drawing is given in Figure 6-2.

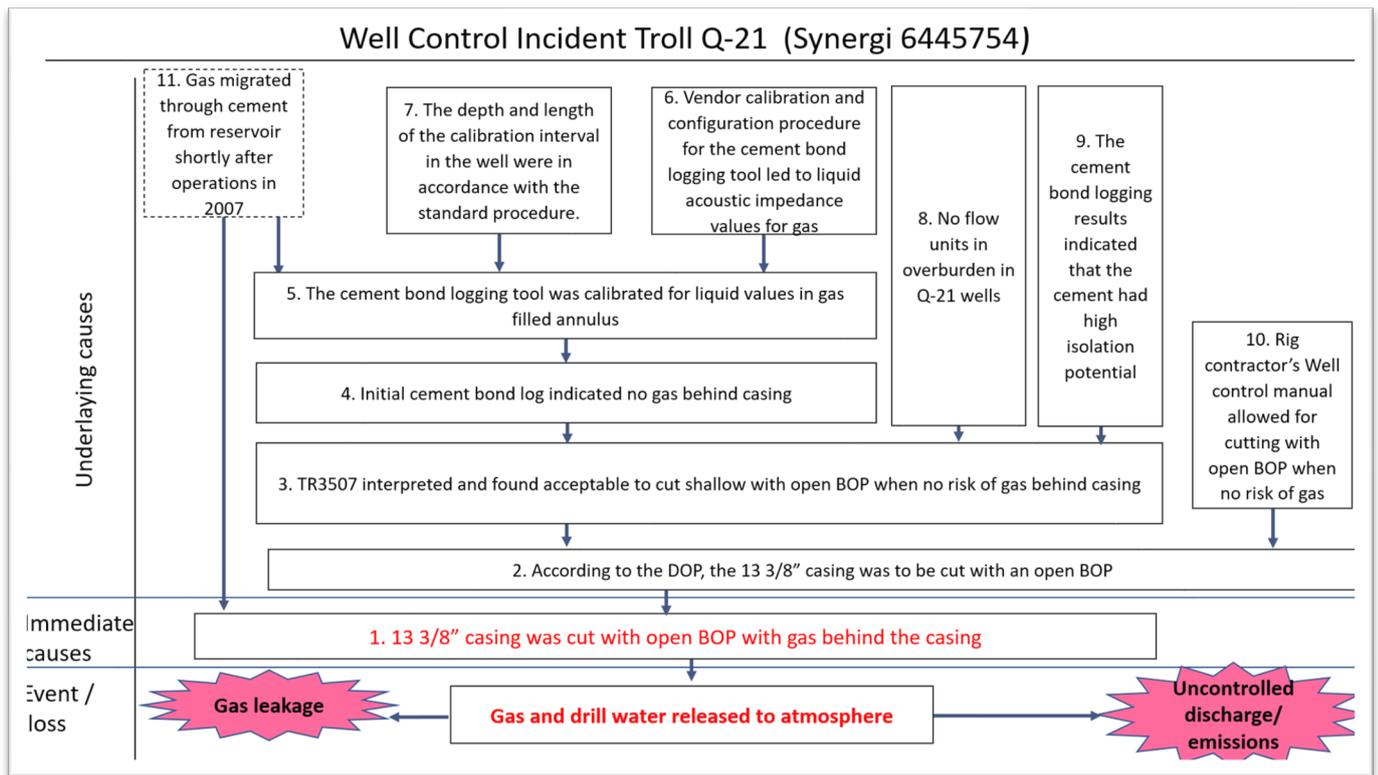
Figure 7-1: Causal map well control incident Troll Q-21

The immediate causes to release of gas to the atmosphere were cutting of the 13 3/8” casing with open BOP in combination with the presence of gas behind the 13 3/8” casing.

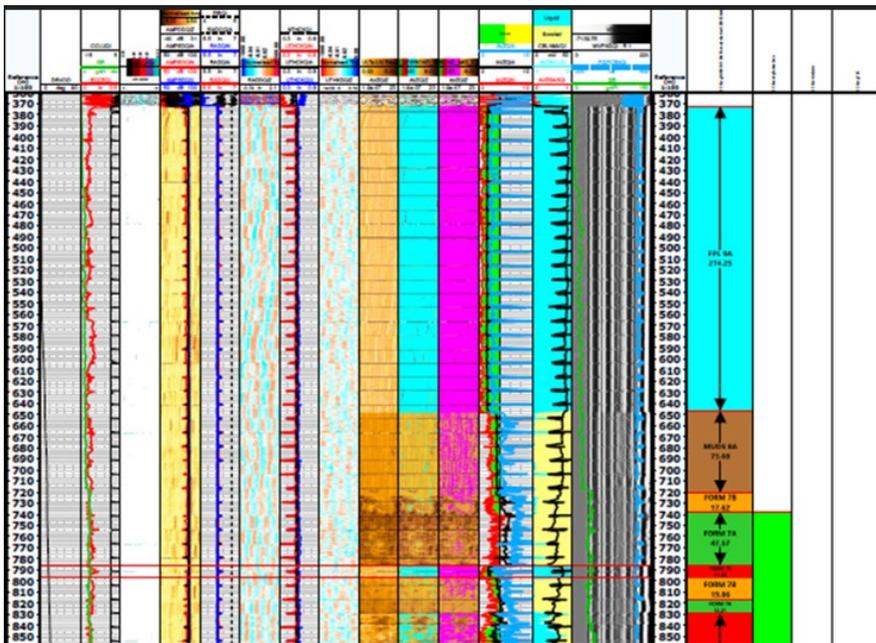
Figure 7-3: Azimuthal impedance map

During calibration of the cement bond logging tool, acoustic impedance readings were outside the expected range for liquids. In accordance with the vendor's procedure, a constant in the algorithm was disabled, which caused gas-filled annulus readings to appear as liquid values.

The blue colour in the azimuthal impedance map in Figure 7-3 indicates liquid filled annulus.
