EQUINOR CANADA LTD.

ENVIRONMENTAL SEABED SURVEY PROGRAM 2023 REPORT

ENVIRONMENTAL SEABED SURVEY PROGRAM

2023 REPORT

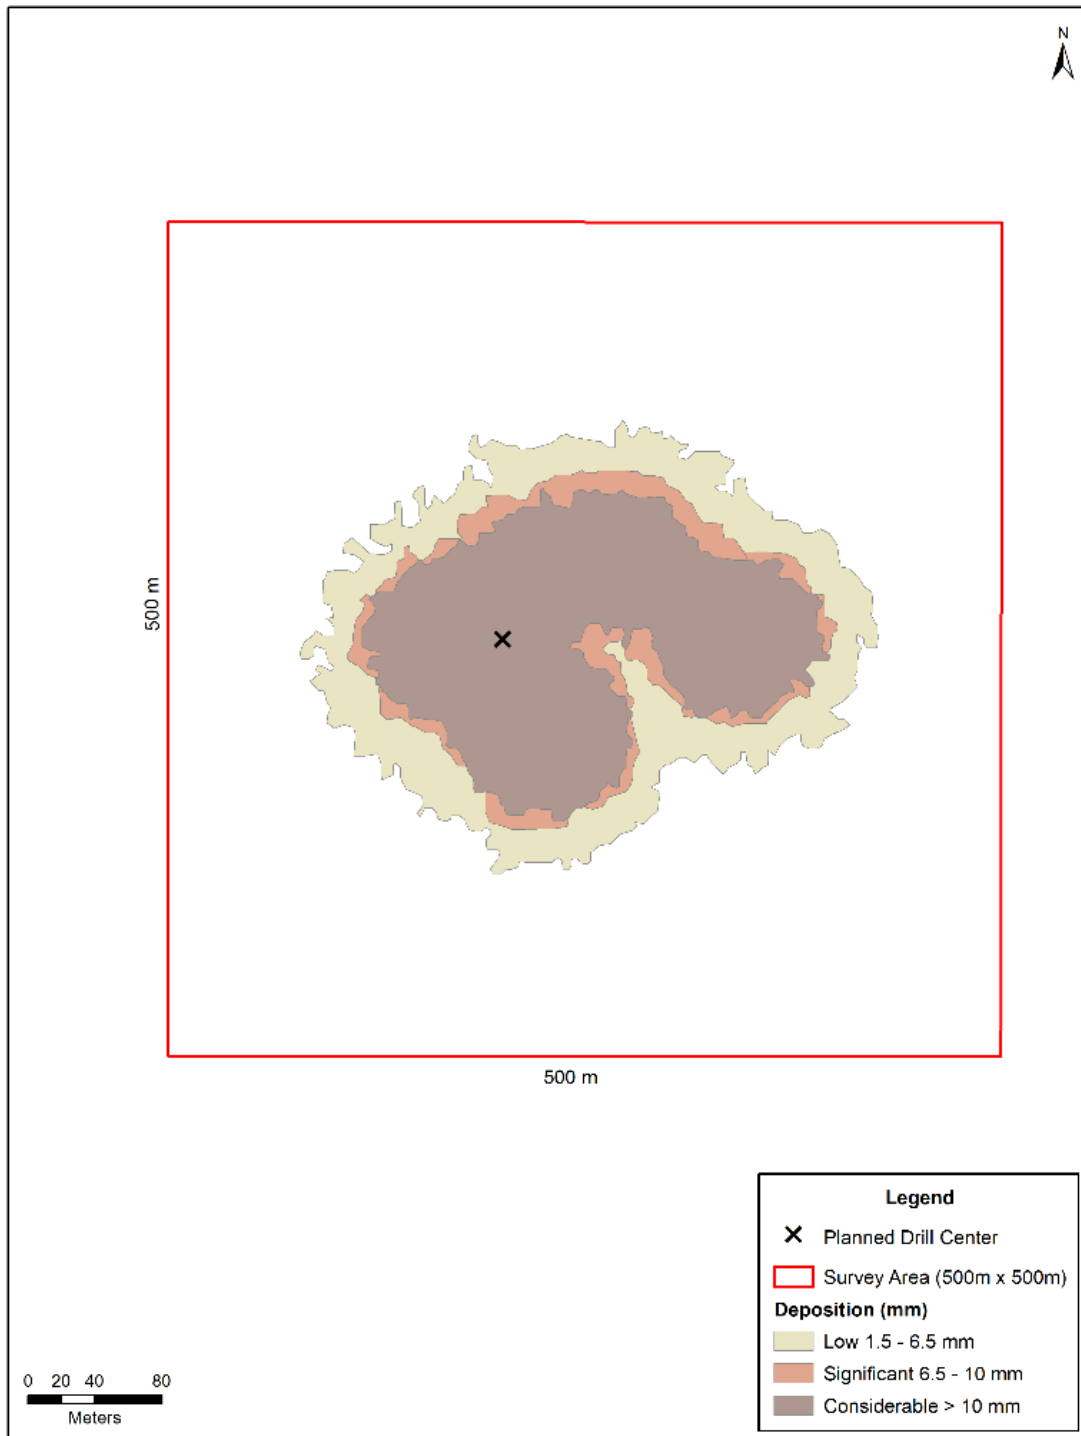
Figure 1-2 Combined predicted drill cutting footprint (WBM and SBM) for exploratory wellsites.

The EPA drill cutting model included the combined deposition distribution of both water-based mud (WBM) and synthetic-based mud (SBM) discharges. To capture the seasonal variation in ocean currents experienced over the course of a year, modelling was conducted for four different 'scenarios' (for March, June, September, and December). Drilling activities in the Newfoundland offshore typically occurs over the late spring to early fall timeframe. To represent the most conservative scenario, the drill cuttings model used in this plan consists of the maximum depositional value and spatial extent from the four seasonal models combined.

To assess the potential effects of drill cuttings on benthic fauna, a threshold of 1.5 mm predicted no effect threshold (PNET) was applied to the model results (Kjeilen-Eilertsen et al. 2004, DFO 2022). Potential effects from sedimentation thresholds of 1.5 mm and 6.5 mm (combined WBM and SBM accumulations) were also considered in the EIS (Statoil 2017). Studies on the effects of sedimentation and burial from drill cuttings on benthic invertebrates have found the effects to be mainly localized to the vicinity of the cuttings pile (Neff et al. 2000, Gates and Jones 2012). The PNET for non-toxic sedimentation (based on benthic invertebrate species burial tolerances) is an average burial depth of 6.5 mm (Kjeilen-Eilertsen et al. 2004, Smit et al. 2006). However, burial tolerance can vary between species and a burial threshold of 1.5 mm has been suggested as a conservative threshold to assess drill cutting burials (Kjeilen-Eilertsen et al. 2004). Areas below the 1.5 mm PNET are predicted to have no adverse effect to benthic fauna.

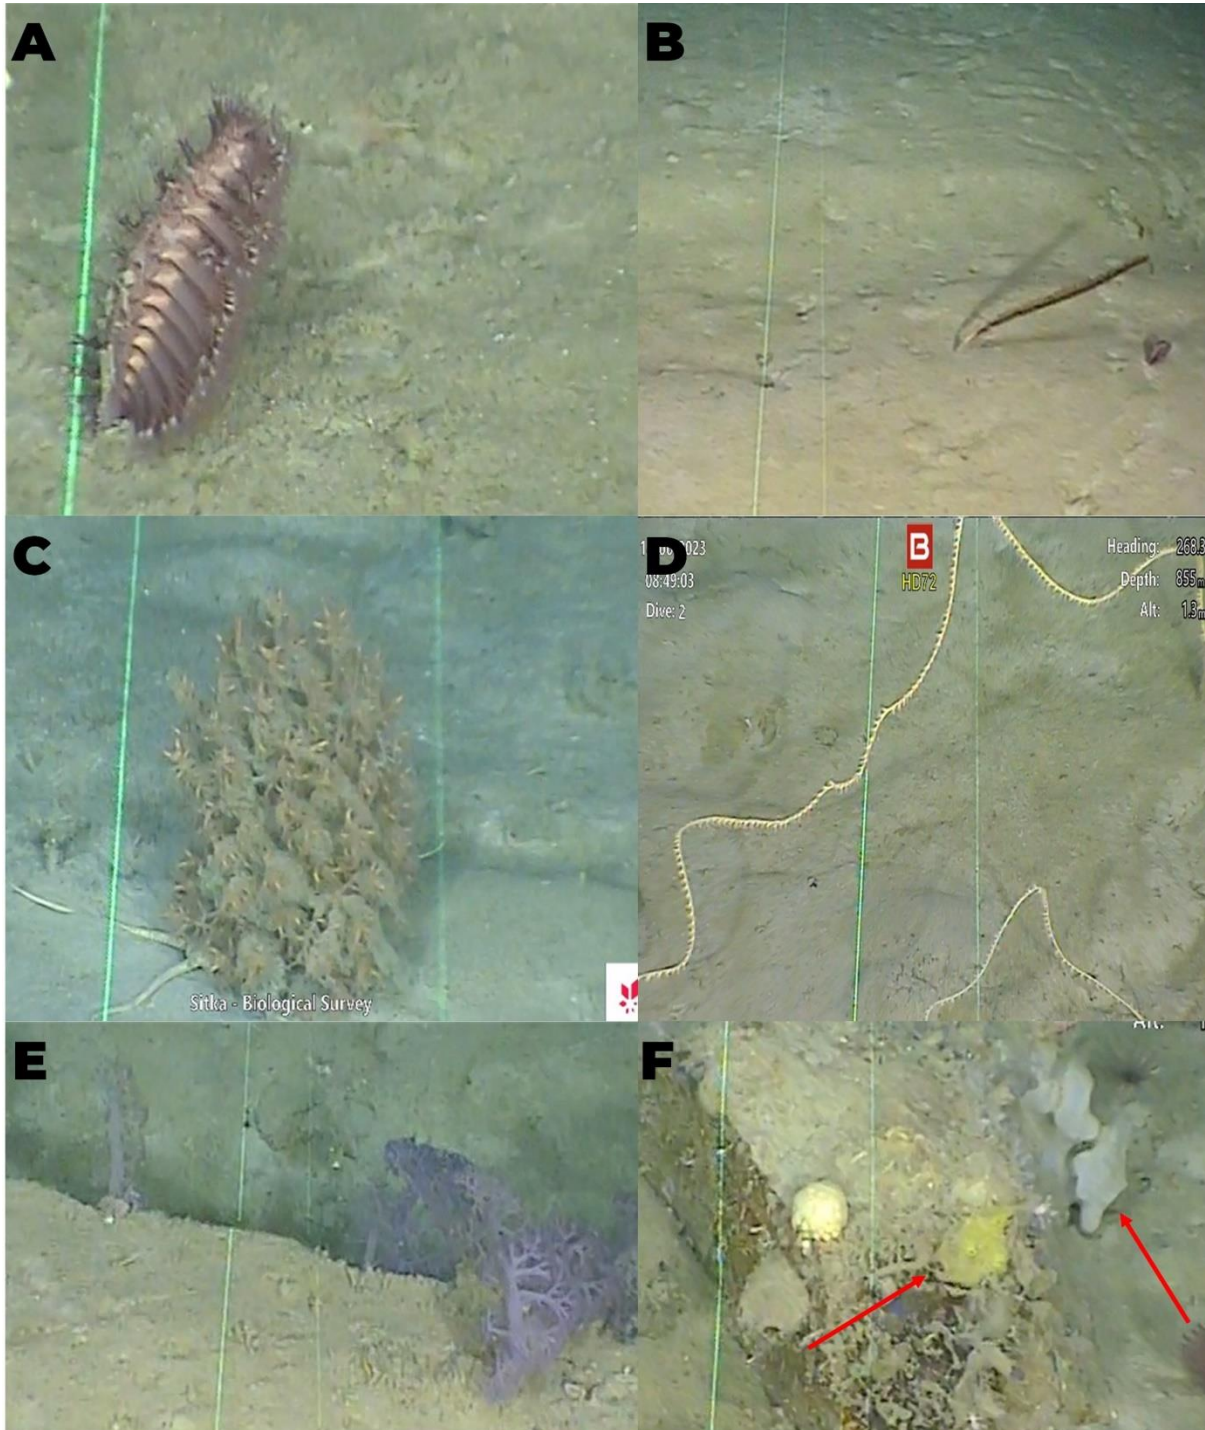
- The primary substrate class observed was fine with sporadic coarse and medium substrates (Figure 3-3).
- A total of 68,841 individual corals were observed from three functional groups sea pens, small gorgonian, and other corals (e.g., soft and hard corals). Sea pens (consisting mainly of *Pennatula* spp.) occurred in the highest total abundance ($n = 67,418$). Small gorgonians (mainly *Acanella* sp.) were also present ($n=1,337$) as were soft and hard corals ($n= 83$ and $n=3$, respectively) (Table 3-1, Figure 3-1).

Figure 3-1 Representative photos of coral and sponge functional groups observed. A) Sea pen (*Pennatula* sp., condition 'Good'), B) Sea pen (*Balticina* sp.), C) Small gorgonian (*Acanella* sp., condition 'Damaged'), D) Small gorgonian (*Radicipes* sp.), E) Other coral (soft corals), F) Sponges (red arrows). Green lasers are 10 cm apart.

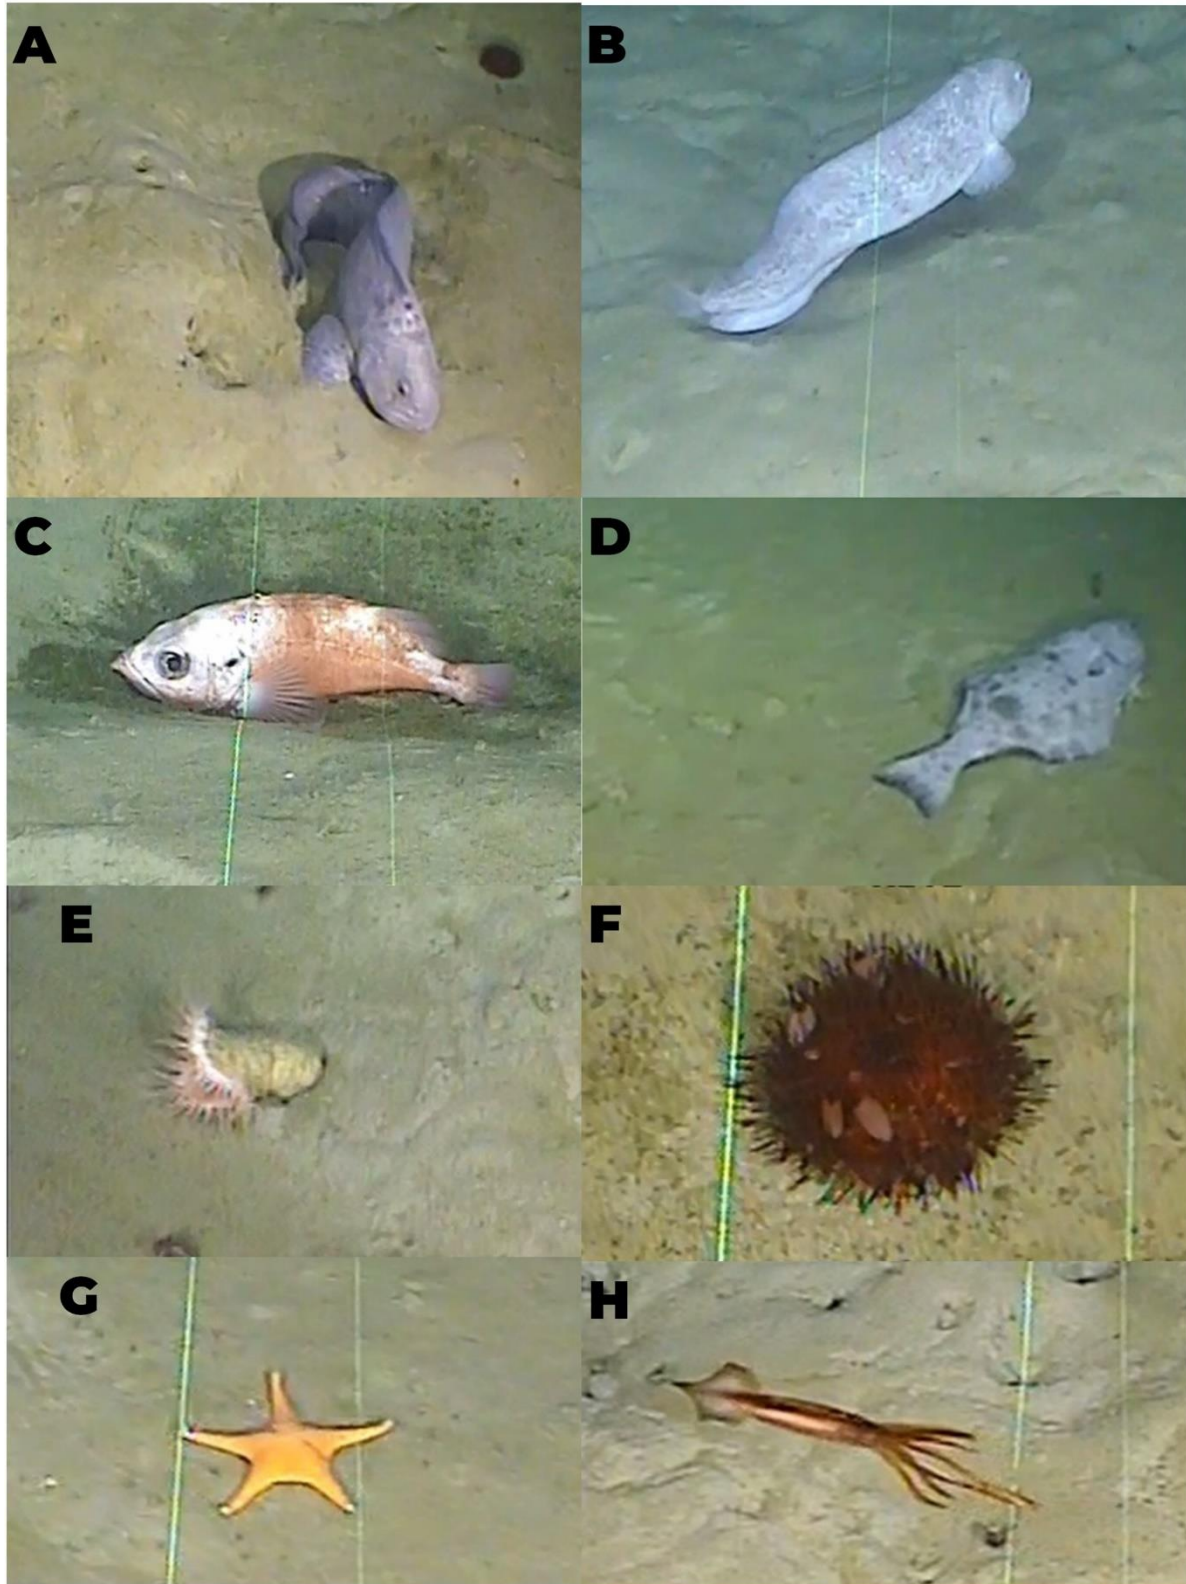
commonly observed. Two redfish and two wolffish were also observed within the survey area (Figure 3-2).

Figure 3-2 Representative photos of other taxa and observations. A) Benthivore (Spotted Wolffish sp., B) Benthivore (Atlantic Wolffish sp.), C) Plank-piscivore (Redfish), D) Piscivore (halibut), E) Cnidaria (anemone), F) Echinoderm (sea urchin), G) Echinoderm (sea star), H) Mollusc (squid). Green lasers are 10 cm apart.

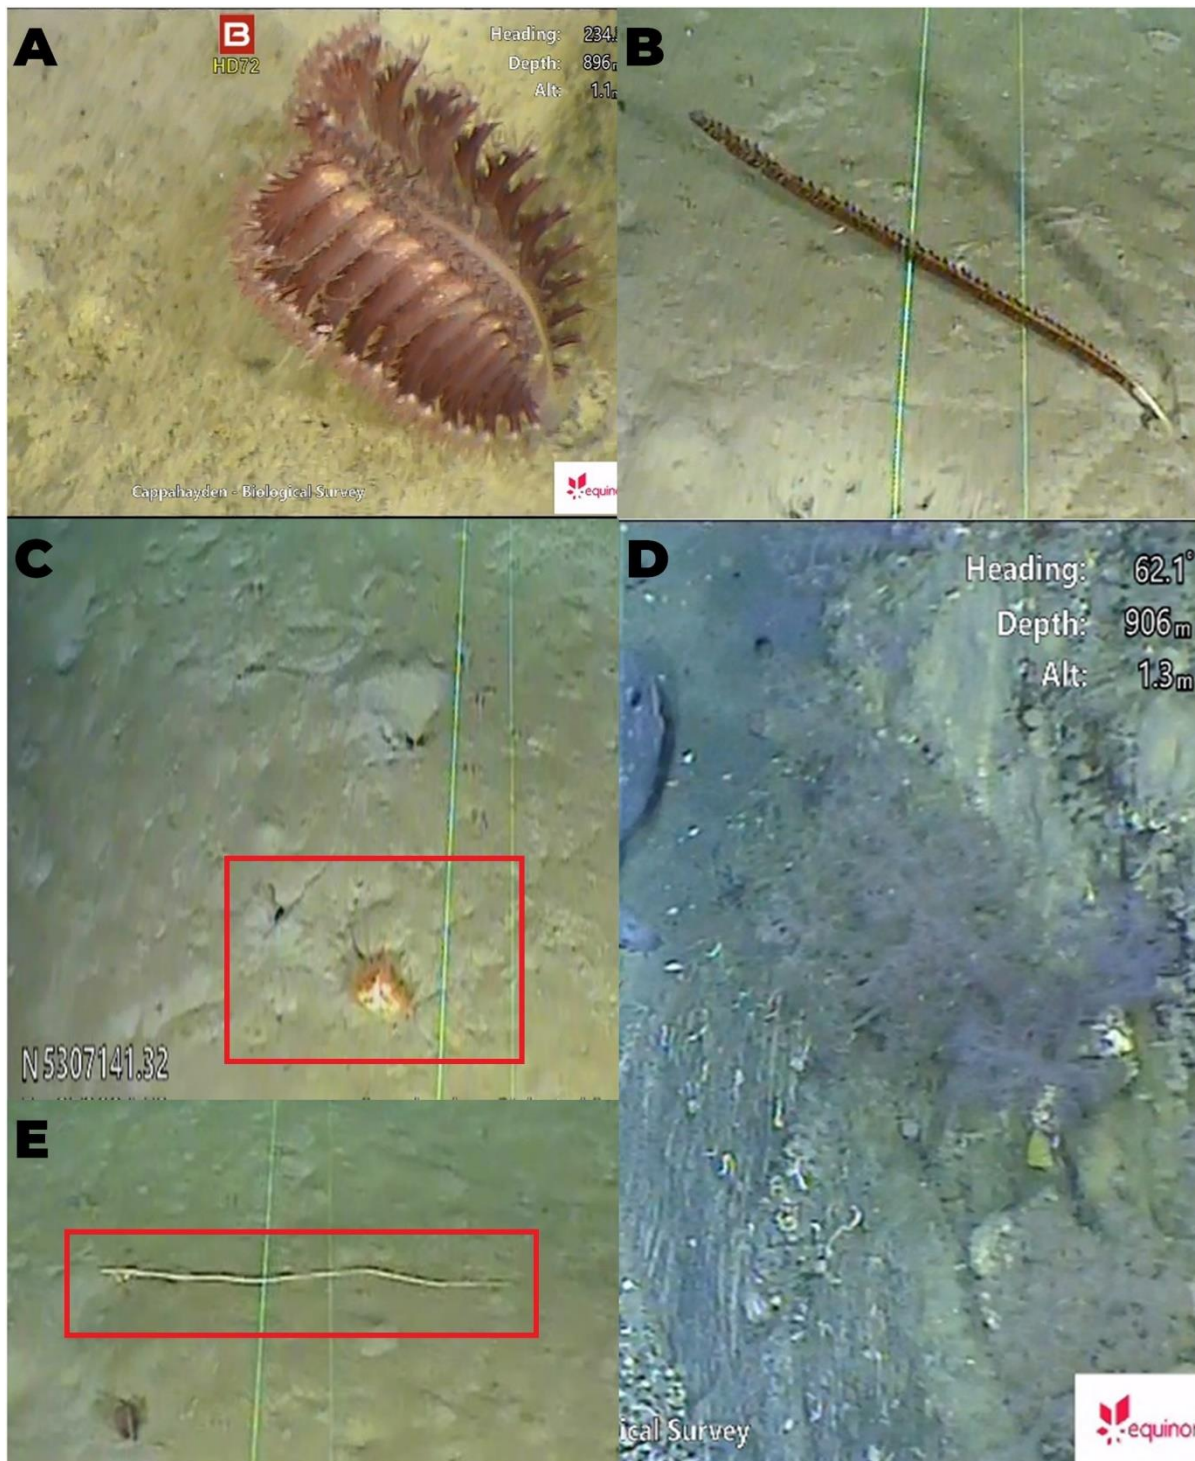
Figure 3-14 Representative photos of coral and sponge functional groups observed. A) Sea pen (*Pennatula* sp.), B) Sea pen (*Balticina* sp., condition Good), C) Other coral (hard coral in red box), D) Other coral (soft coral), E) Example of a coral with the condition Dead (in red box). Green lasers are 10 cm apart.

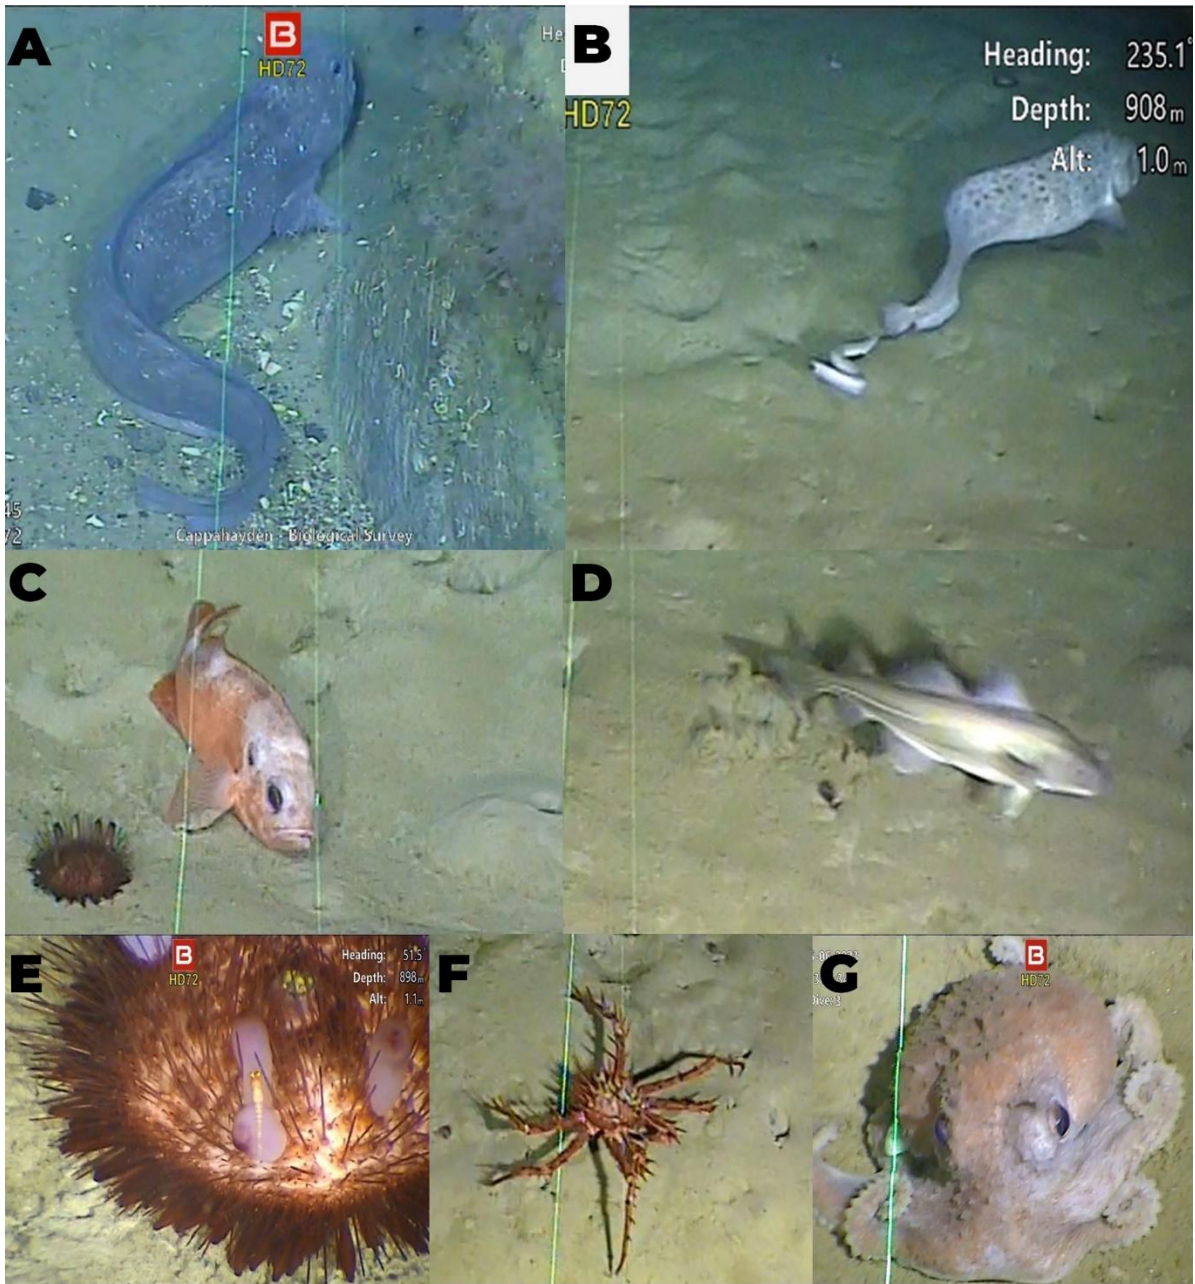
- All four fish functional groups were also present within the Cappahayden survey area. Benthivores (mainly grenadiers) were most commonly observed (Table 3-5). Four wolffish (two spotted and two Atlantic) and three redfish were also observed within the survey area (Figure 3-15).

Figure 3-15 Representative photos of other taxa. A) Benthivore (Atlantic Wolffish), B) Benthivore (Spotted Wolffish), C) Plank-piscivore (Redfish), D) Piscivore (Atlantic Cod), E) Echinoderm (sea urchin), F) Arthropod (crab), G) Mollusc (octopus). Green lasers are 10 cm apart.

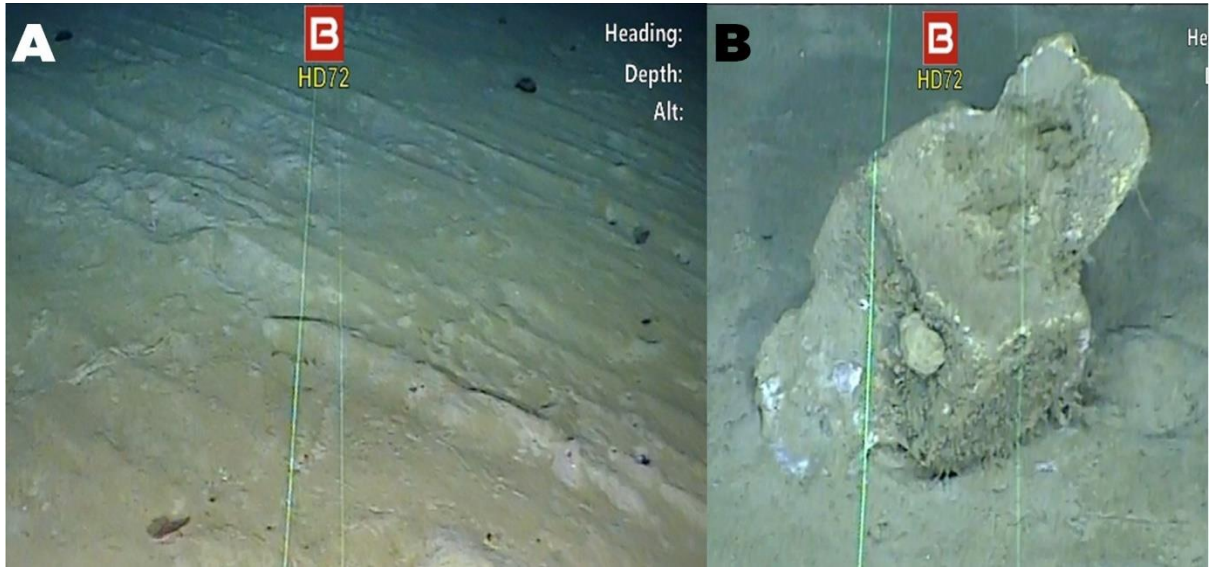
- Other invertebrates observed during the survey included echinoderms (sea urchins), arthropods (crab), and molluscs (octopus) (Table 3-6).
- Trawl marks were present throughout the area. In total 413 of 617 sections had the presence of trawling. There was also scattered debris present as well as a whale vertebra (Figure 3-16).

Figure 3-16 A) Representative photo of trawl marks and B) a whale vertebra. Green lasers are 10 cm apart.

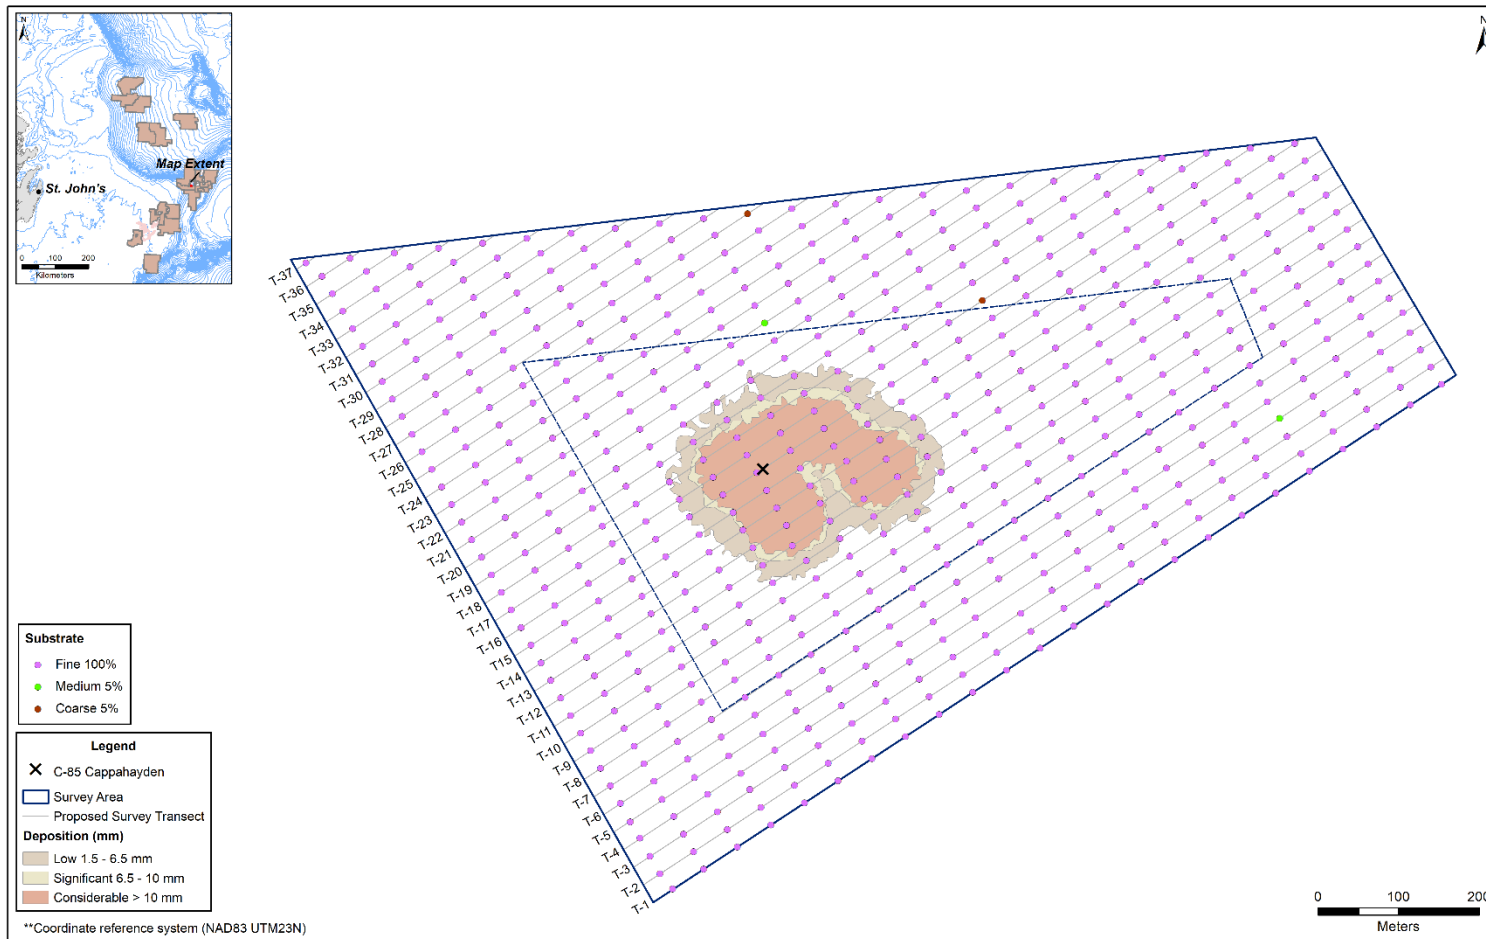
Figure 3-17 Largest grain size percent present for the Cappahayden wellsite area (by section)

- The primary substrate class observed was fine with sporadic coarse and medium substrates (Figure 3-17).
- The coral functional groups sea pens, small gorgonian, and other corals (e.g., soft and hard corals) were present (Table 3-4). Sea pens occurred in the highest abundance (n = 76,980 ind.) and consisted mainly of *Pennatula* spp. (Figure 3-14). Other sea pen species observed included the whip-like species *Balticina* sp. and *Distichoptilum gracile*. Small gorgonians (*Acanella* sp. and *Radicipes* sp.) were also present (n=183) as were soft and hard corals (n=115 and n=15, respectively). Approximately three percent of the total corals observed were deemed to be in the Damaged or Dead condition (Figure 3-24).

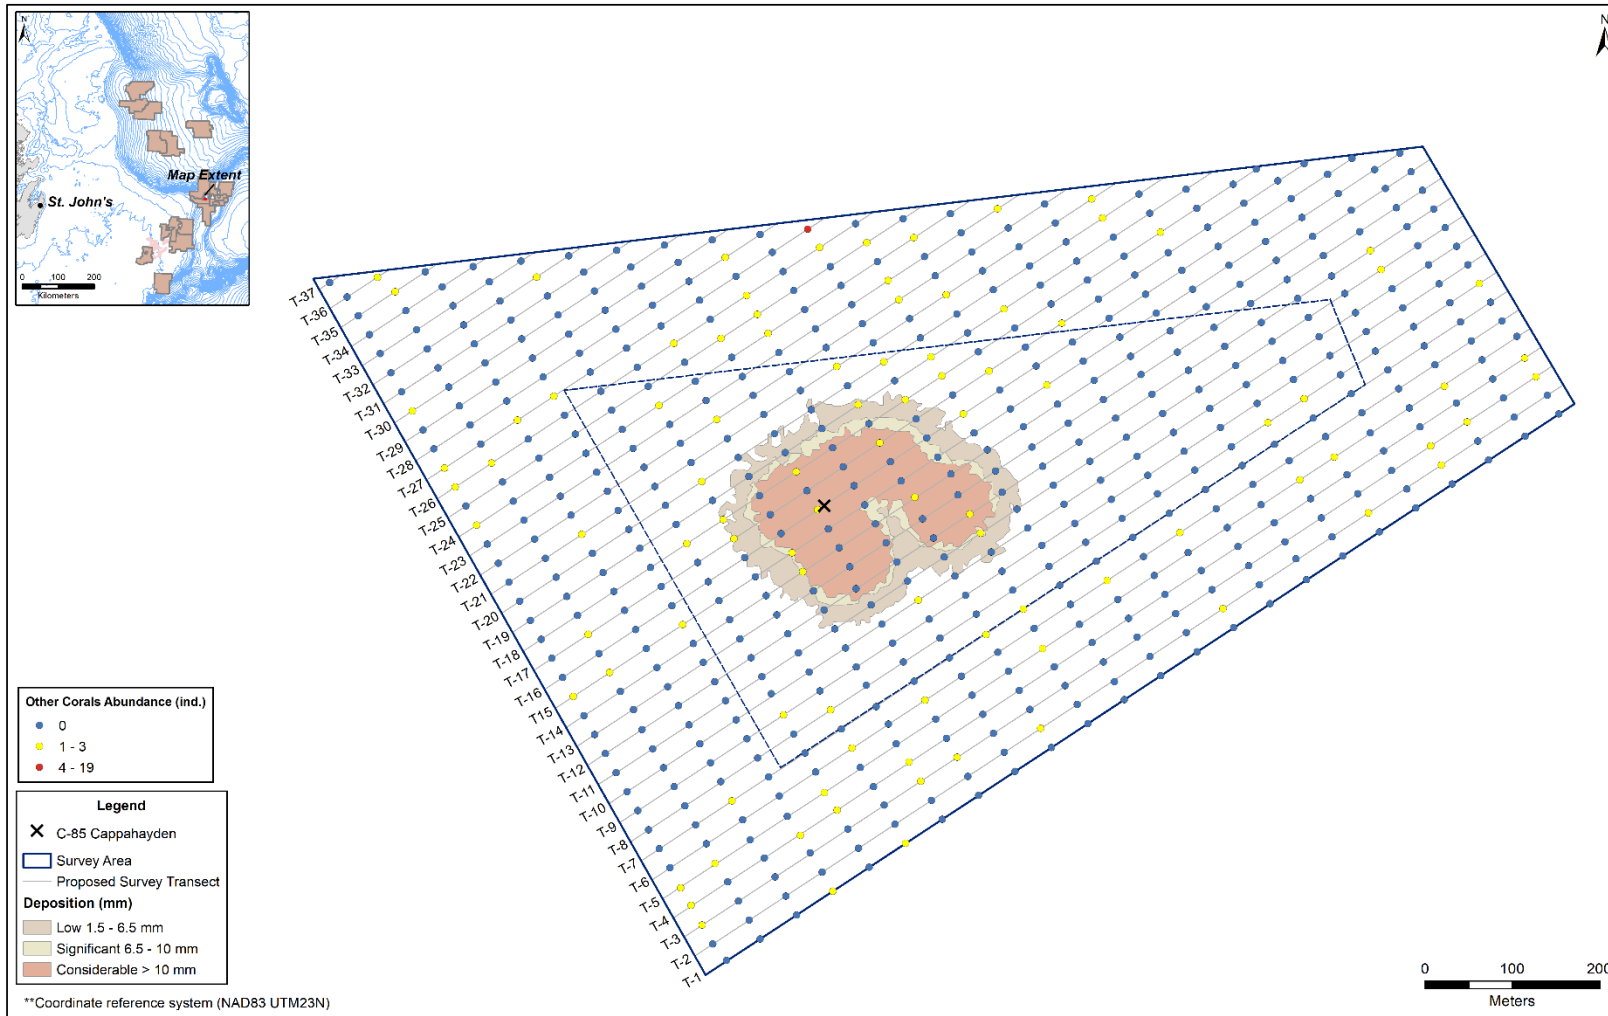
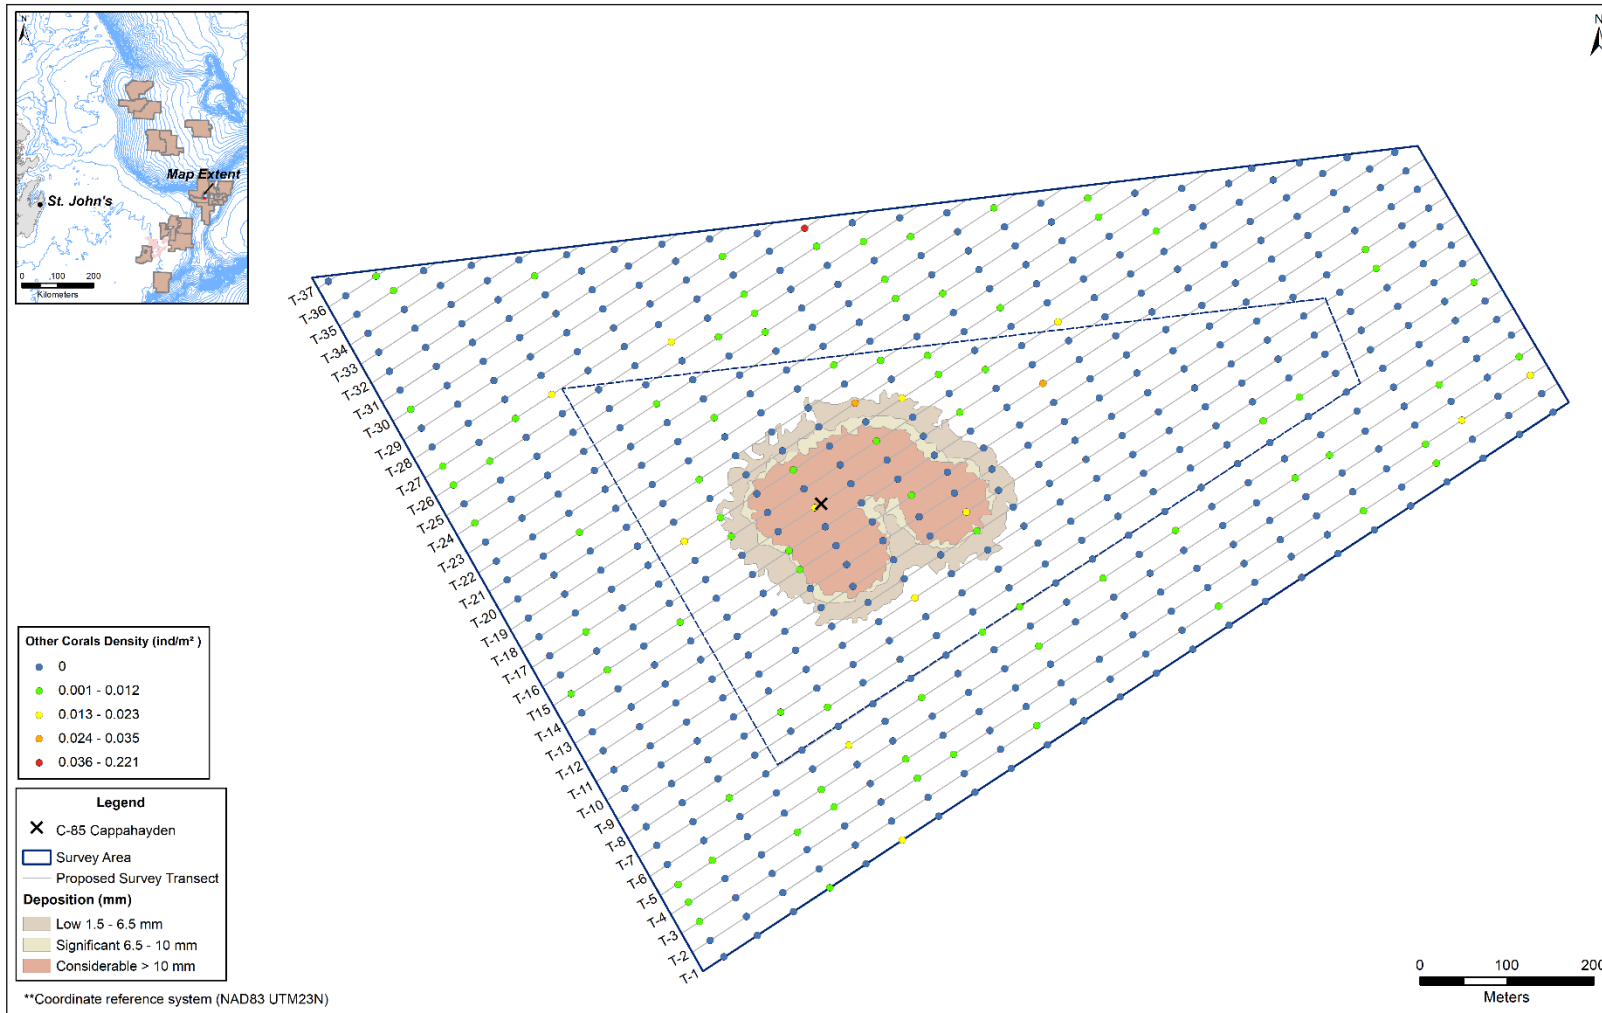
- No large gorgonians or black corals were observed with in the survey area.
- The highest abundance/density of sea pens were observed towards the northwest and southwest corners of the survey area with the lowest occurring in the eastern portions of the survey area (Figure 3-18, Figure 3-19). Small gorgonians were sparsely distributed and observed throughout the survey area (Figure 3-20, Figure 3-21). Other corals were also sparsely distributed and observed throughout the survey area (Figure 3-22, Figure 3-23).

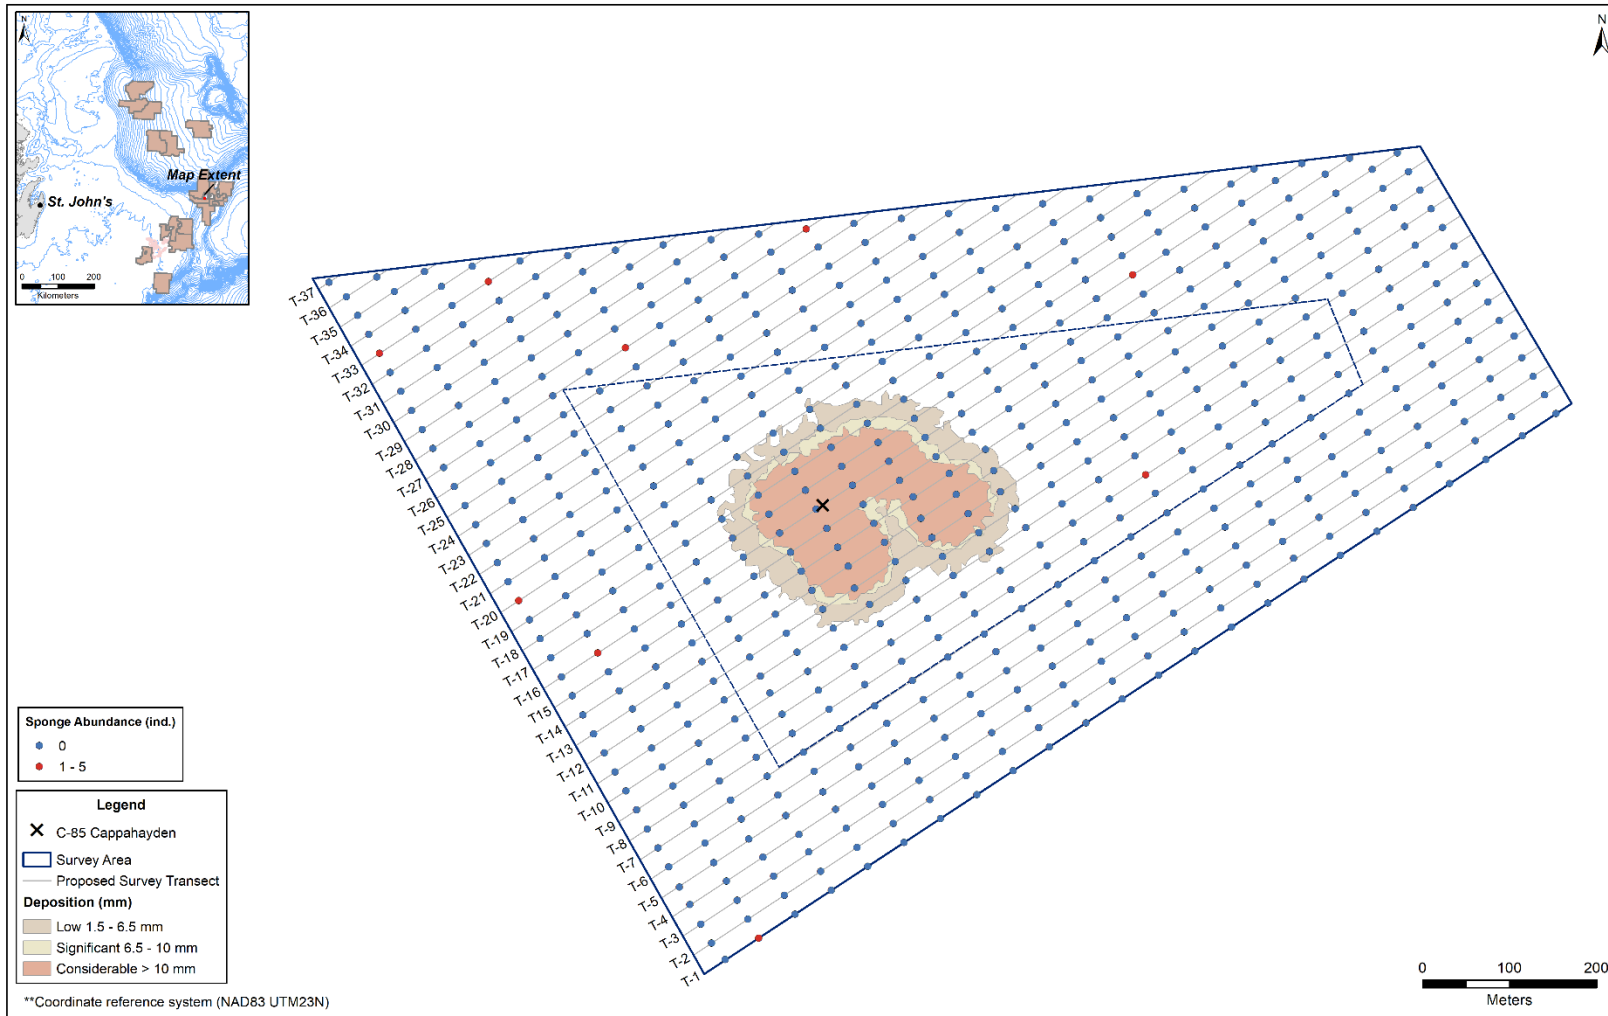
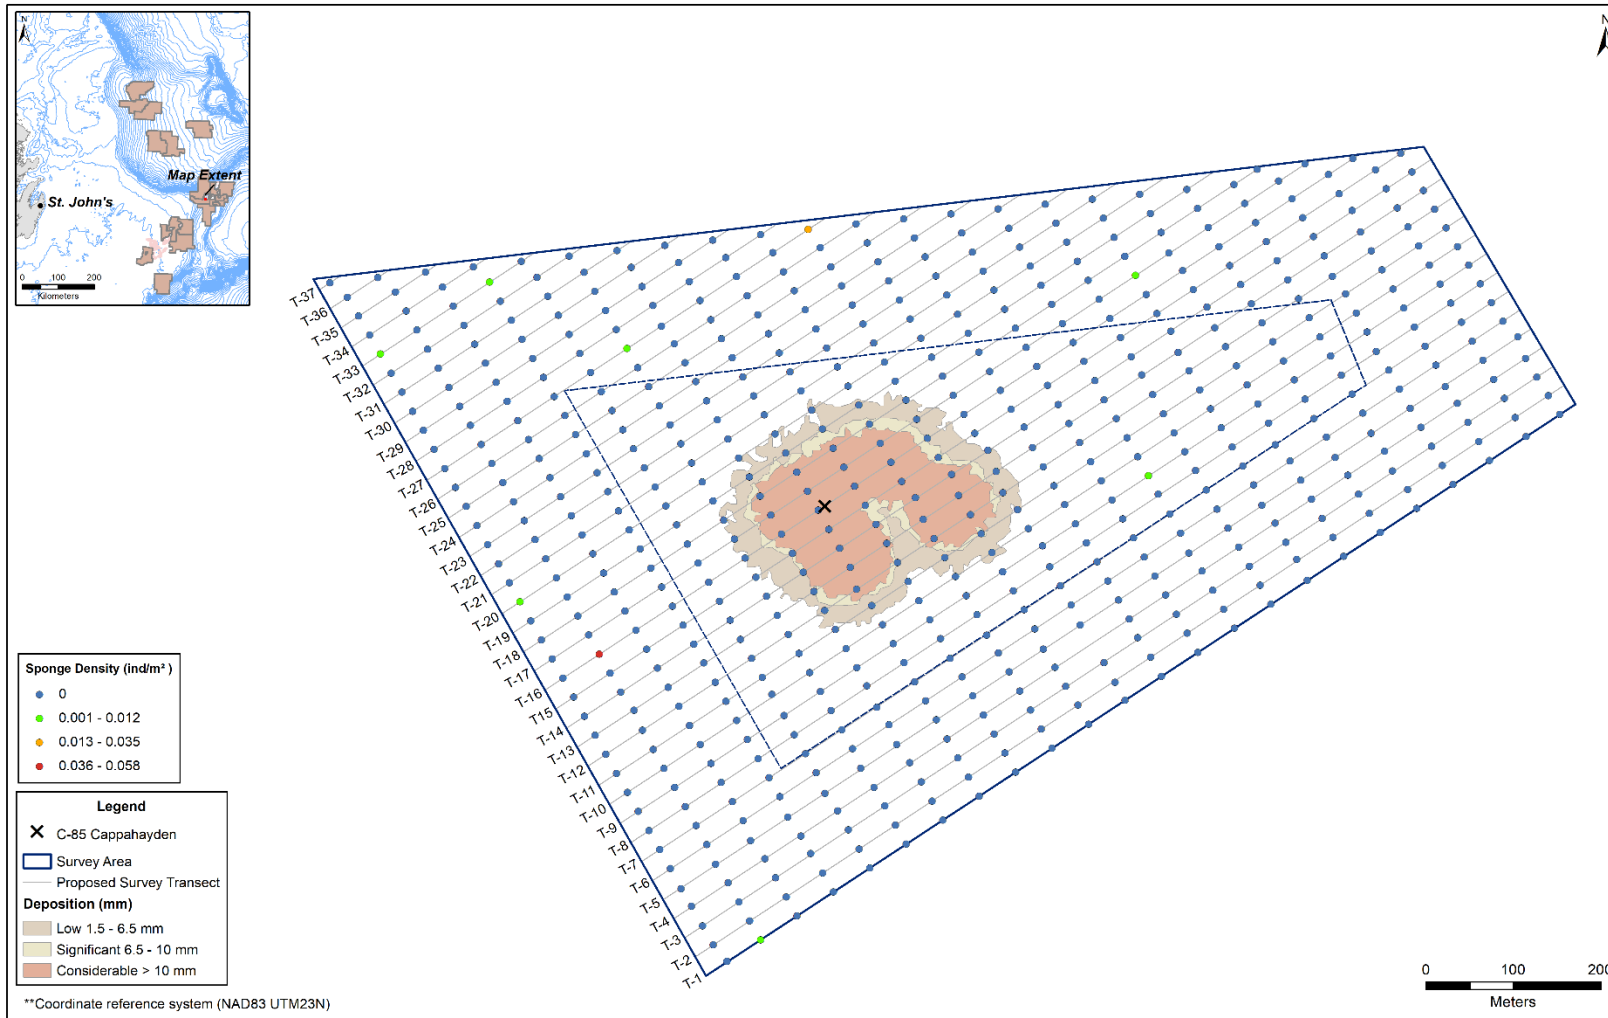
- Sponges were rarely observed in the survey area with a total of 15 individuals observed (Figure 3-25, Figure 3-26). The overall condition of these sponges was good with 33% deemed in Poor/Damaged condition (Figure 3-27).

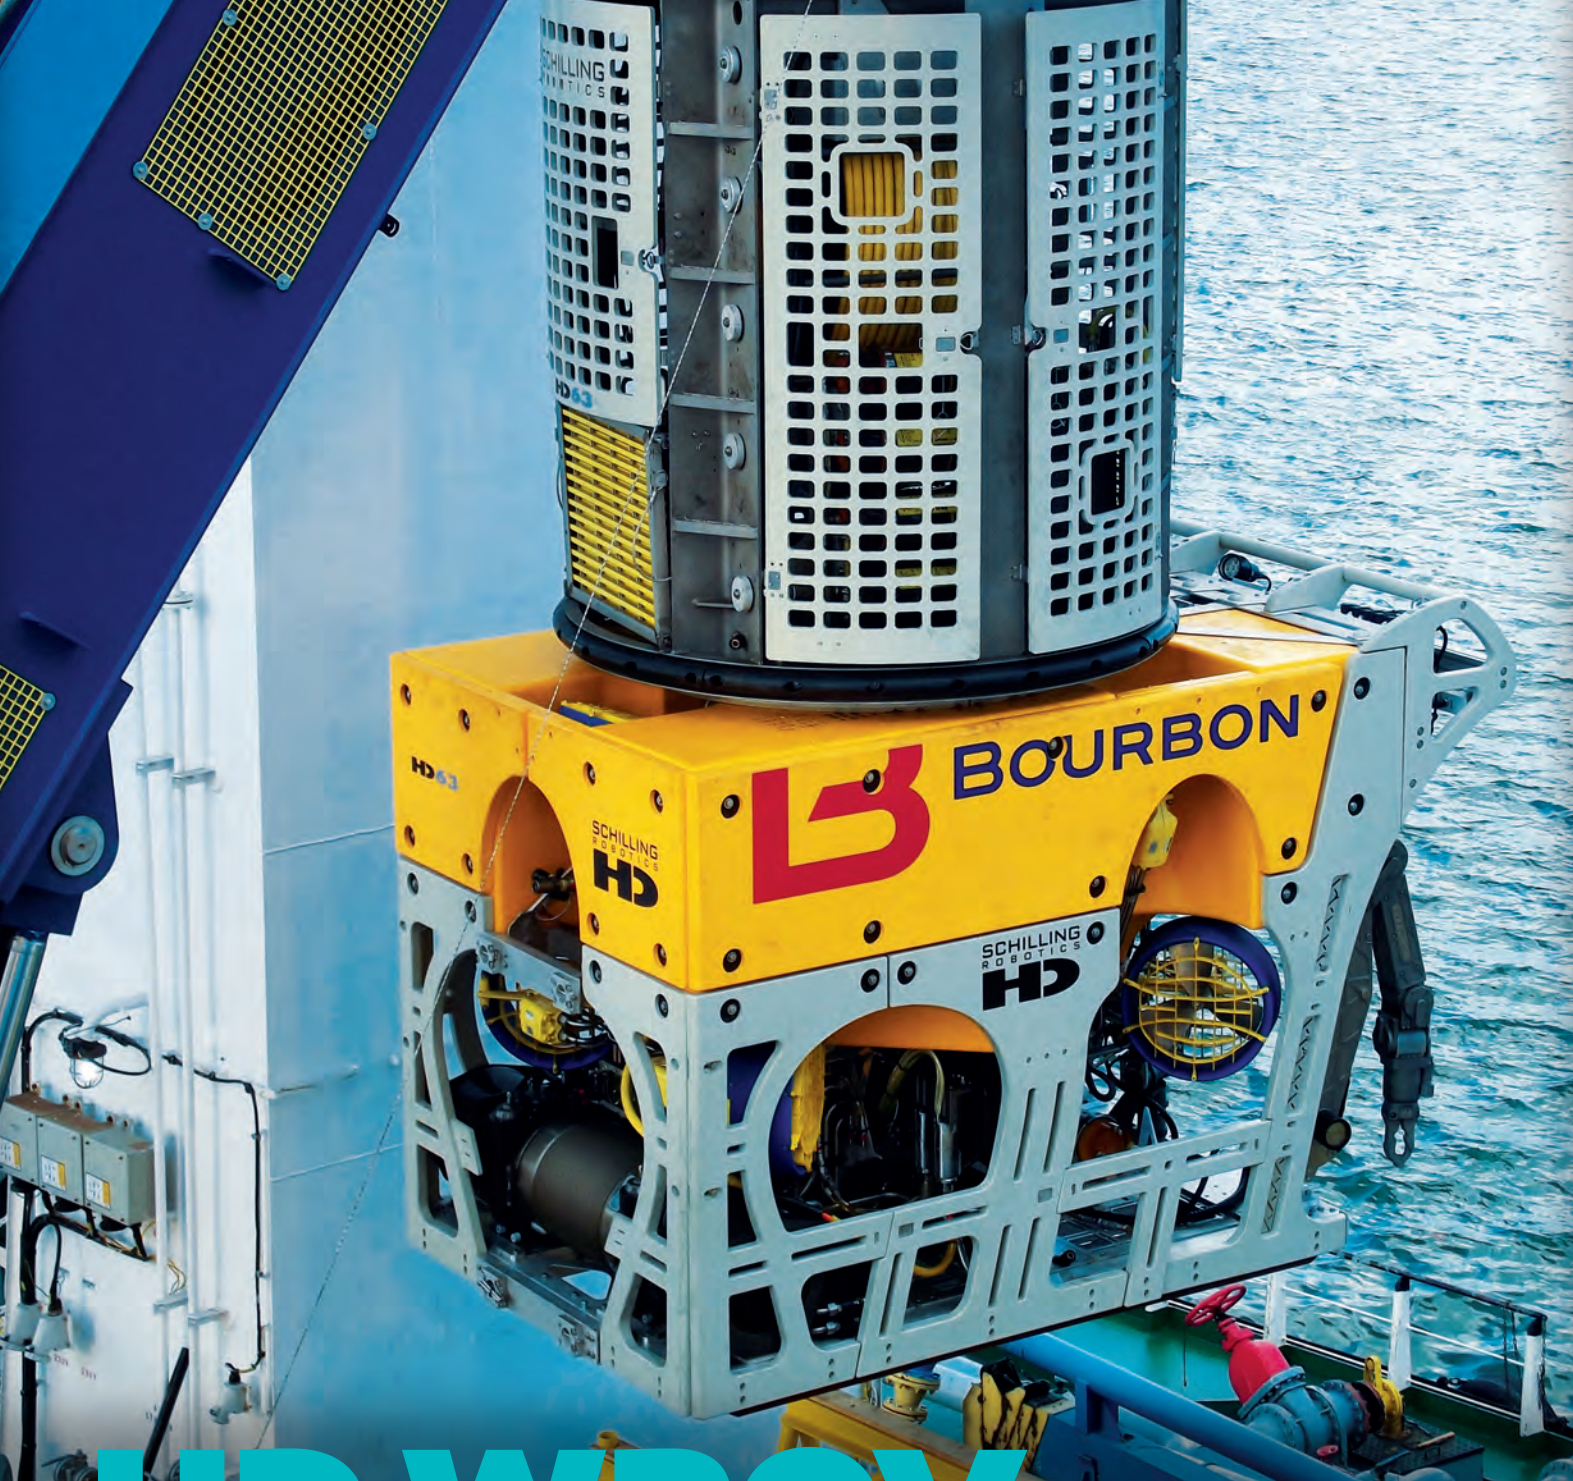
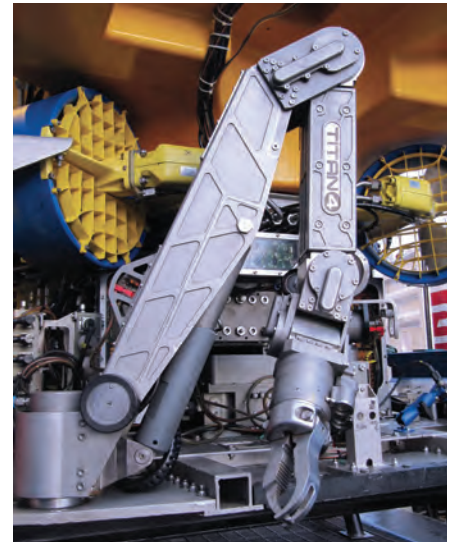
HD WROV SYSTEM

Class III Remotely Operated Vehicle

Innovative features in the frame design and modular subsystems produce a high performance vehicle suitable for IMR, drill support, and construction operations, while maintaining a compact system footprint.

- Separate hydraulic circuits: main for propulsion and manipulators, auxiliary for tooling
- Automatic heading, depth, altitude, attitude, auto-tuning, and StationKeep
- AutoTrack utility to control vehicle through survey coordinates
- Digital Telemetry System: serial, video, Ethernet through Gigabit backbone
- Optional 1080i FULL-HD video capability on multiple cameras
- New-generation FMC Schilling "Hammerhead" operating system
