Investigation report

Internal accident investigation

Well Control Incident Troll Q-21

Classification:	Internal	Status:	Final
Report no.:	N/A	Date:	02.03.2026
Expiration date:	N/A	Synergi no.:	6445754

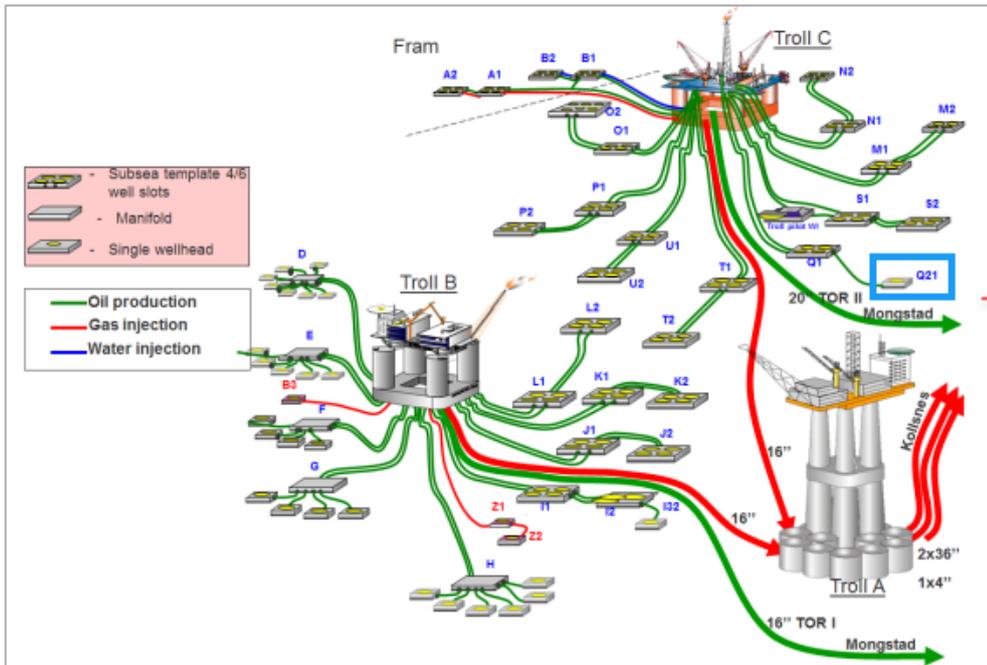
Figure 3–2: Illustration of wells, templates and oil, gas, and water pipelines in the Troll field. Q-21 indicated by blue frame is a single wellhead.

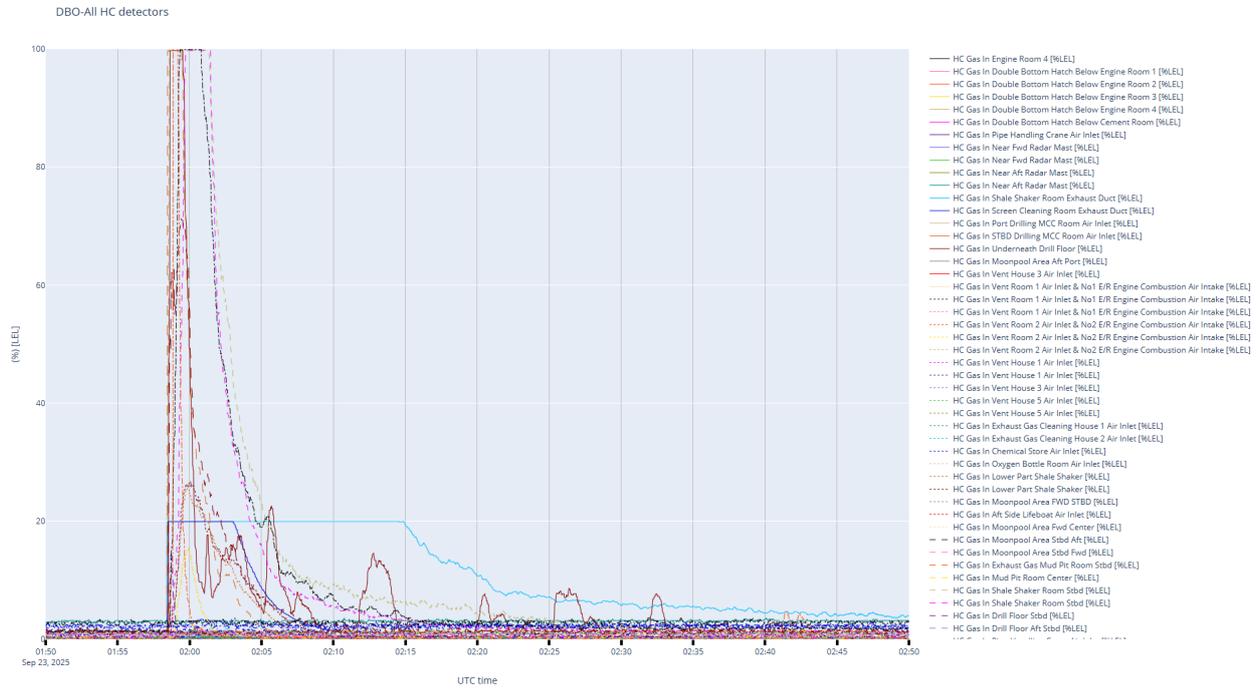
Figure 4-11 shows illustration of gas measurements on the rig in all areas with duration.

Figure 4-11: Illustration of gas measurements on the rig in all areas with duration

The gas release resulted in a condition where the HC concentration reached 100% LEL in both the shaker room and on the drill floor.

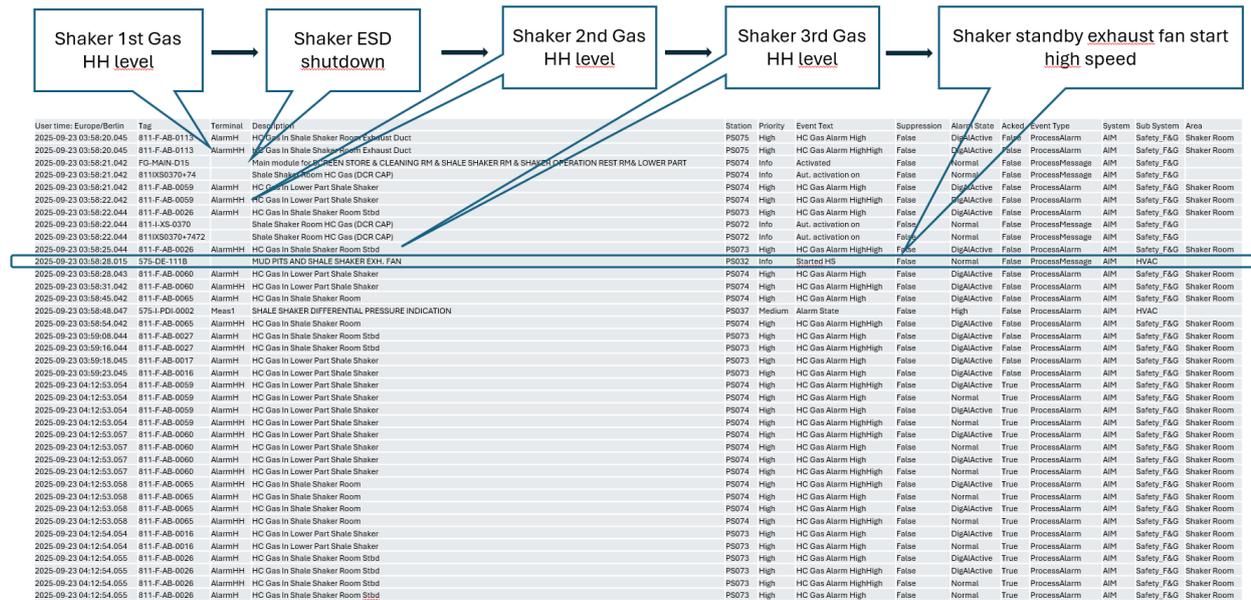
Figure 4-12: Key events from K-IMS event log with timestamp of events for confirmed gas and ESD shutdown activation.
