Investigation report

Investigation of SAR-helicopter safety in Equinor after the helicopter accident 28 February 2024

Security classification: Open	Status: Final – released – translated copy
Report: A 2024-6 EPN L1	Synergi: 3104729

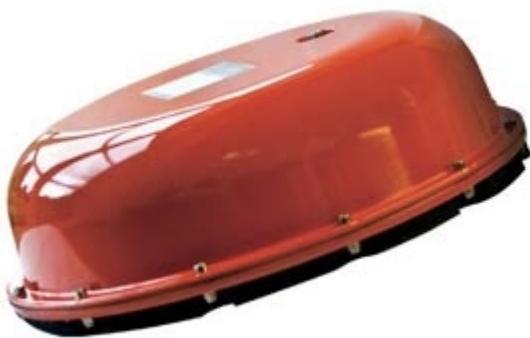
Figure 3-13 Emergency locator transmitter in the SAR helicopter (source: Website for HR Smith, Ref /78/)

Both Bristow and CHC use the same emergency beacon in the SAR helicopters: Automatic Deployable ELT (ADELT), 15-503-134 -ELT, ARTEX C-406-N or CPI (HR Smith) **(Ref /37/ and /38/)**.

The emergency locator transmitter can be operated manually from a panel in the cockpit, or automatically from a crash sensor (multi-axis accelerometer) or by a switch activated by water. It detaches from the helicopter, floats, and sends out a signal with GPS coordinates for the last known position.

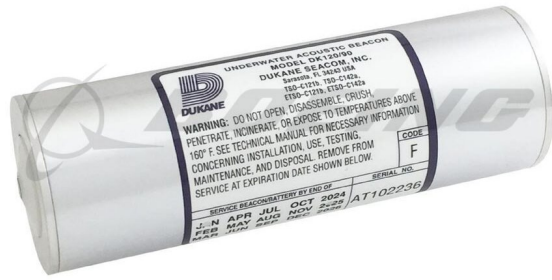
Figure 3-14 Emergency beacons in the SAR helicopter (source: Dukane website, Ref /79/)

Both Bristow and CHC use the same acoustic transmitter to locate the flight recorder of an underwater helicopter: the Dukane DK 120 Underwater Locator Beacon (Ref /37/ and /38/).

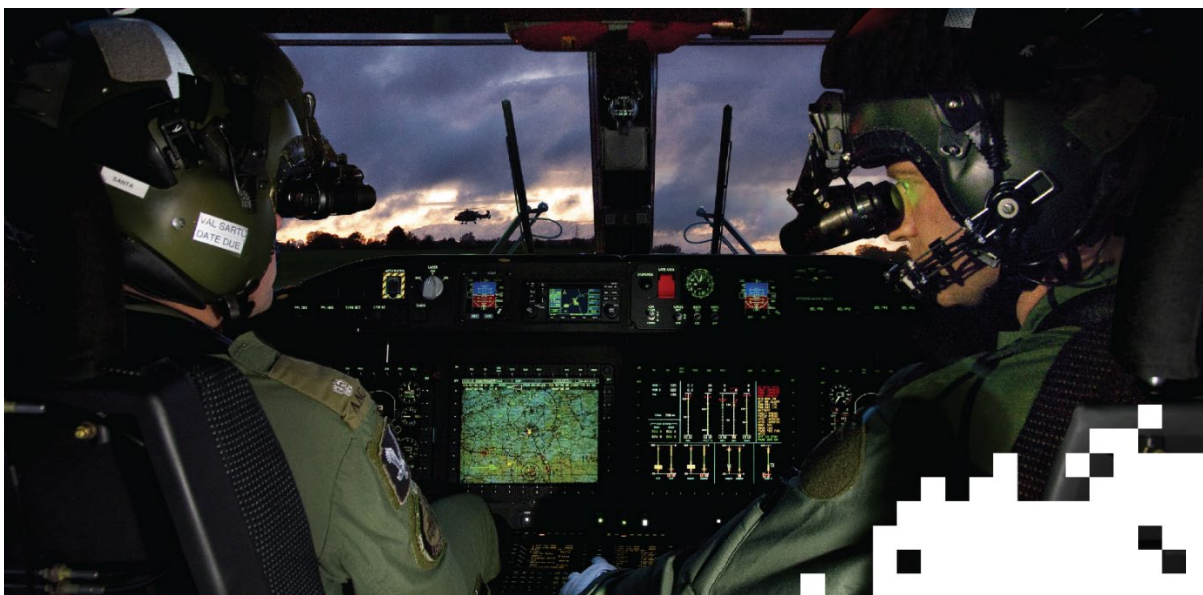
Figure 3-15 Night vision goggles (NVG) for helicopter pilots (source: Leonardo helicopters website, Ref /81/)

In the contracts with both Bristow and CHC (Ref /37/ and /38/), it is specified that there must be three night vision goggles (NVG) in the rear cabin. These are to be used when visually searching in water during dark or poor visibility. The cabin must therefore be equipped with lights that are compatible with NVG, and windows on both sides must be adapted for searches. The cockpit will also be compatible with NVG, but both contracts specify that any installation, use and qualification of NVG for the pilots will take place by new agreement.

In a meeting with the Rescue Helicopter Service (330 Squadron in the Air Force, see **section 3.3** on page 19) the investigation team was informed that they use NVGs in the cockpit when it is dark. For example, if they are working towards an illuminated vessel, one pilot will take off the NVG, while the other has the NVG activated in case they need to move quickly away from the illuminated area. The pilots of the Norwegian Air Ambulance also use NVG (Ref /71/).

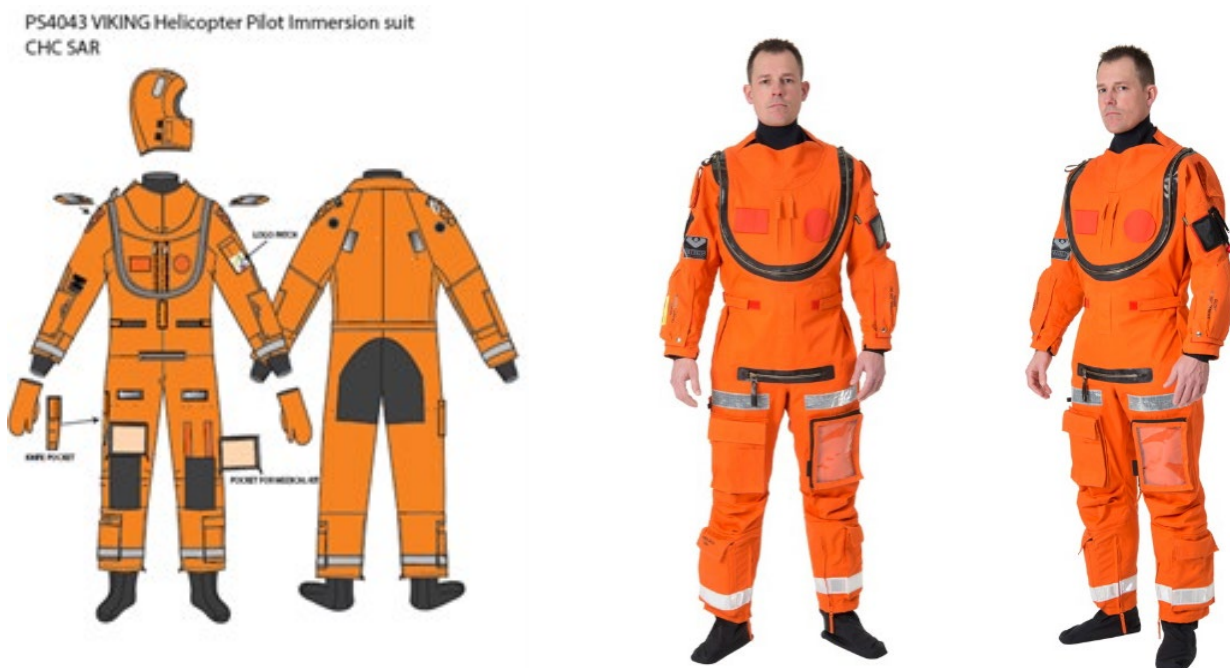
Figure 3-16 Survival suit (sources: Equipment list /33/ to the left and Viking-Life to the right Ref /80/)

From the list of SAR nurse protective equipment: PS4043 Viking Helicopter Pilot Survival Suit CHC SAR. This is equipment that the SAR nurses procure themselves and sends for maintenance at the manufacturer Viking every year. Each SAR nurse therefore needs two survival suits.

Outer fabric: NOMEX® GORE-TEX®

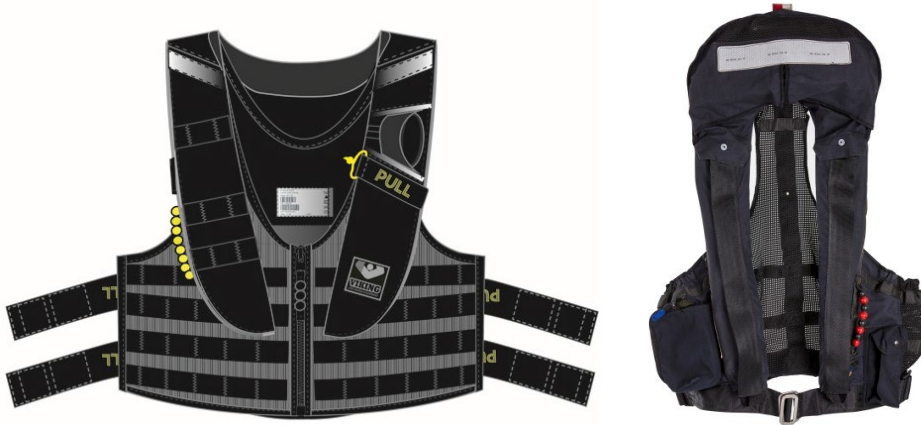
Figure 3-17 Viking life jackets on the left (source: Viking website, Ref /80/) Beaufort MK44 on the right (source: a-ss.no)

According to the current contracts, both Bristow and CHC must use the same type of life jacket for SAR nurses: Viking PV9365 vest with STASS (Short Term Air Supply System), emergency breathing system (CAT A) (Ref /37/ and /38/). However, the responses that the investigation group has received from the SAR nurses in a survey (see **App H**) indicate that there are different types of life jackets in use. The contracts allow for the use of life jackets of a similar type: "Viking PV9365 vests with STASS or similar worn by crew". On the SAR helicopter the investigation team visited at Flesland, the Beaufort MK44 vest is used.

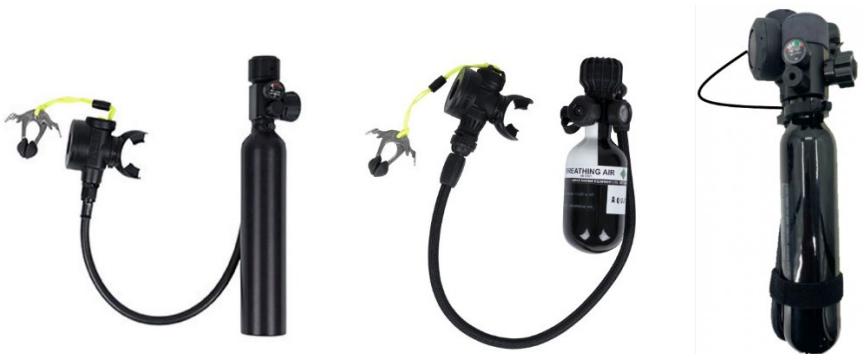
Figure 3-18 Examples of different pressurized emergency breathing systems (source: Viking-Life website, Ref /80/)

Bristow uses Tiger Performance Series 4500, Submersible Systems HEED 3, Aqualung SEA LV 2 og Aqualung SRU-40 B/P (Ref /39/).

CHC uses Poseidon Spare Air (EBS) 4,500psi and FORCE Technology Aqualung LV2, but is in the process of replacing these with Aqualung EBS-System MEER (Ref /40/).

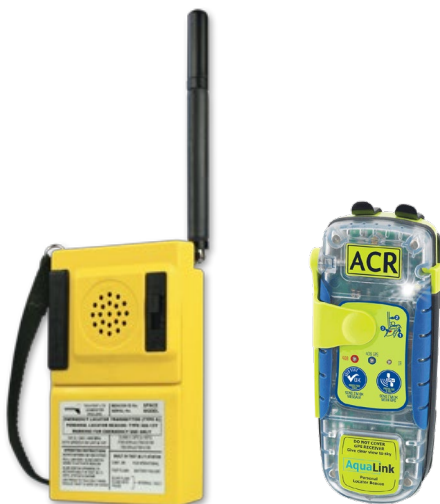
Figure 3-19 Personal locator beacons for SAR crews (source: Website for HR Smith, Ref /76/ and website for ACR, Ref /77/)

According to the contracts, both Bristow and CHC must use the same type of personal locator beacon for the SAR crew, Techtest 500-12Y (Ref /37/ and /38/). On the SAR helicopter Bristow has stationed at Flesland, ACR AquaLink is used.

Both the Techtest 500-12Y and AquaLink must be activated manually by holding down a button for a few seconds, unlike the HPL-2 locator beacons, which after arming are triggered automatically upon contact with water (see **section 3.5.18** on page 33).

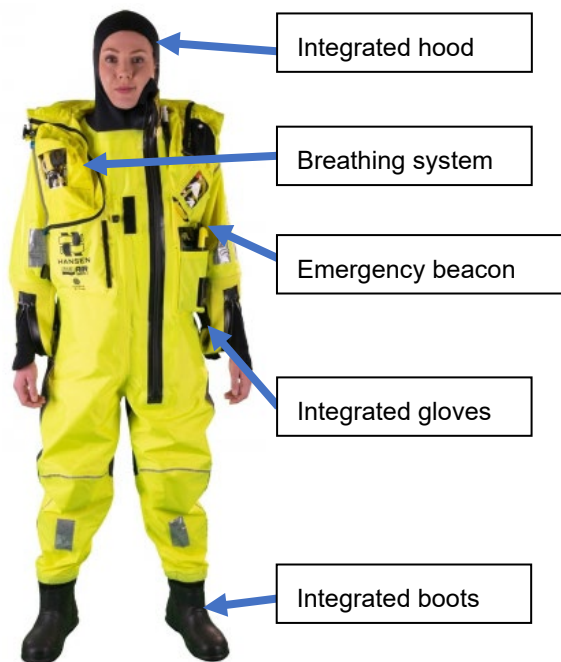
Figure 3-20 Survival suit for passengers in transport helicopters (source: Hansen Protection website, Ref /74/)

The suit has, among other things, an integrated emergency breathing system (see **section 3.5.17**), an antenna module for locator beacons, a hood for splash protection, emergency lights, a buddy line with a floating hook and an integrated harness for lifting during rescue from the sea. The suit has built-in buoyancy and is therefore used without a life jacket. It is possible to inflate the collar manually for a safer floating position. These suits are intended for passengers only and are not suitable for carrying out work in SAR service.

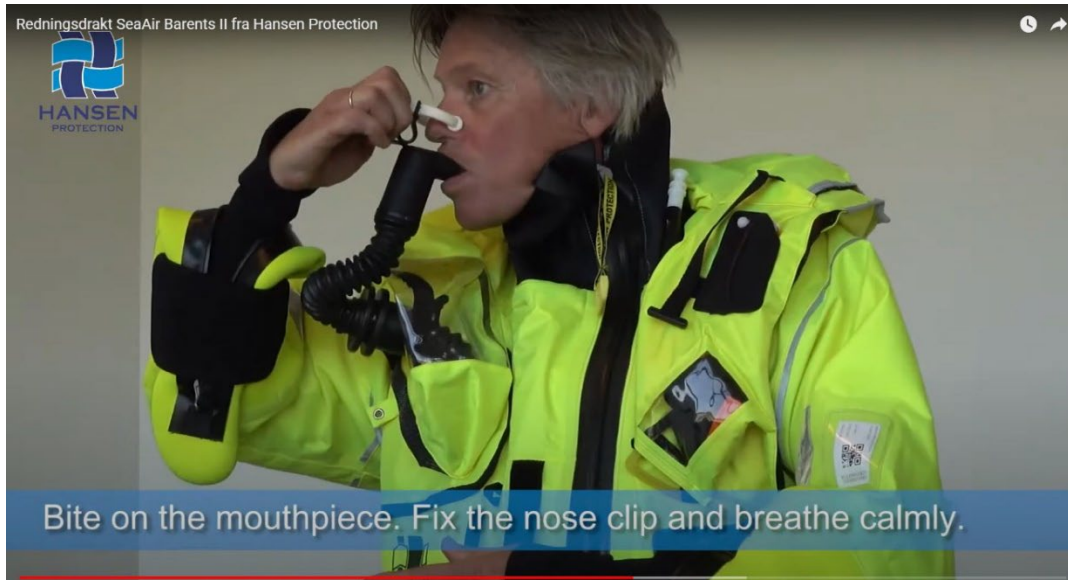
Passengers in transport helicopters have a bag in their survival suit that the user fills with air through a breathing nozzle when the valve in the equipment is activated. This air can then be reused for a period during underwater evacuation if the helicopter has overturned. This emergency breathing system in the delivery service is used with a temporary exemption from the Civil Aviation Authority. They set requirements for breathing systems that can be established underwater, as shown in **section 3.5.10** on page 30.

Figure 3-21 Integrated emergency breathing system in SeaAir Barents II survival suit (source: YouTube video from Hansen Protection, Ref /75/)

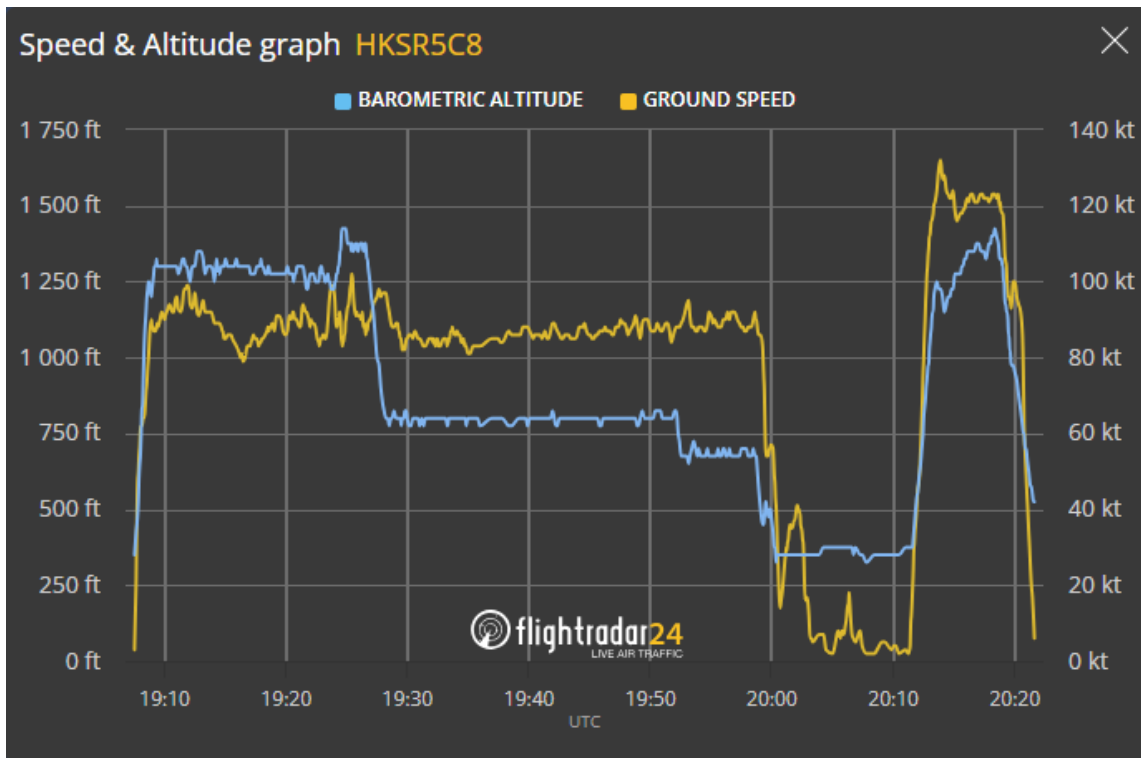
Figure 5-5 Altitude in feet (blue line) and speed in knots (yellow line) for SAR from Florø, LN-OMH / HKSR5C8 (Source: Flightradar24)

The altitude and speed of the two rescue helicopters are shown in **Figure 5-4** and **Figure 5-5**. Note that here too, one hour must be added to get the local time.

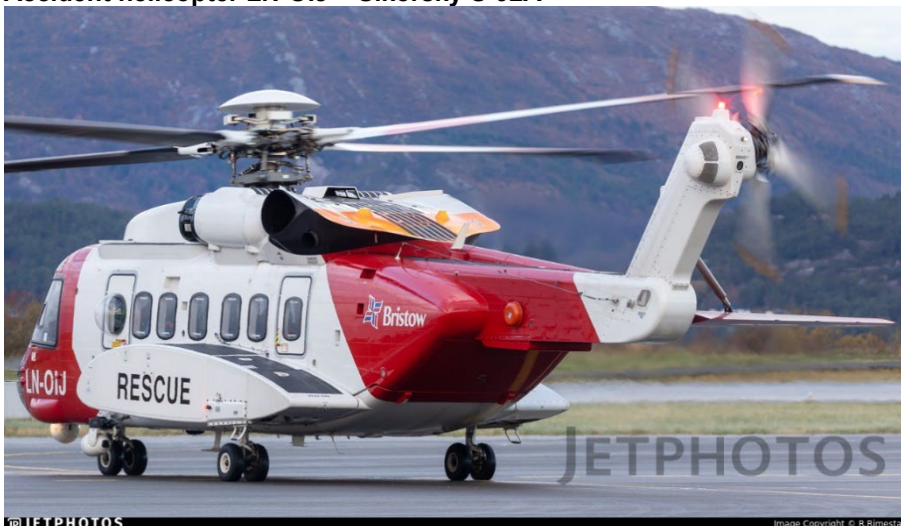
Accident helicopter LN-OIJ – Sikorsky S-92A

The S-92A helicopter, with serial number 92-0169, was produced in 2011 by Sikorsky, USA. The helicopter was taken over by Bristow in 2013 and operated by Bristow for Her Majesty's Coast Guard. From 2019, it was operated by Bristow for oil and gas activities in the UK sector until it was taken over by Bristow Norway from February 2023 ([Ref /84/](#)). The SAR helicopter has five seats for SAR crew in the rear cabin. The S-92A as a transport helicopter has 19 passenger seats.

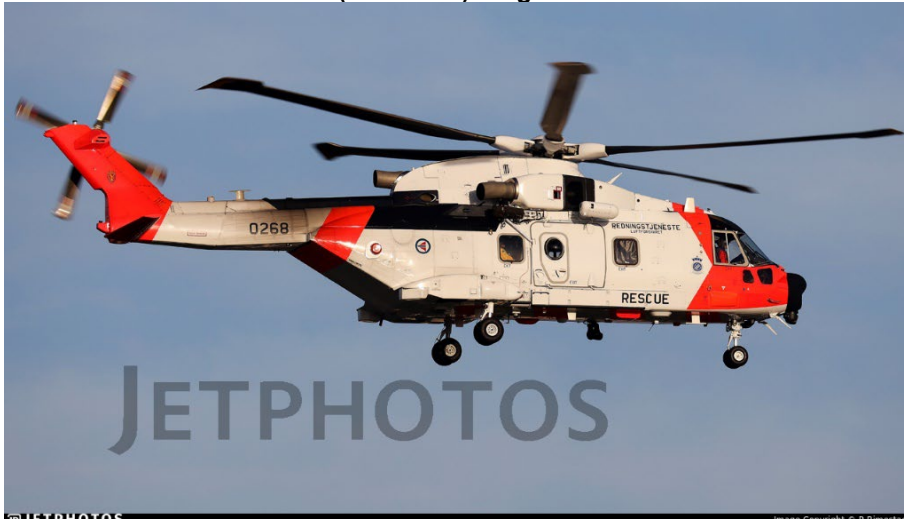
SAR Queen from Sola 0268 (SAVER50) – AgustaWestland AW101 Merlin Mk.612

The AgustaWestland helicopter with serial number 50268, was manufactured by Leonardo Yeovil, UK, and delivered to the Norwegian Air Force in 2017 (Source: Helis.com).

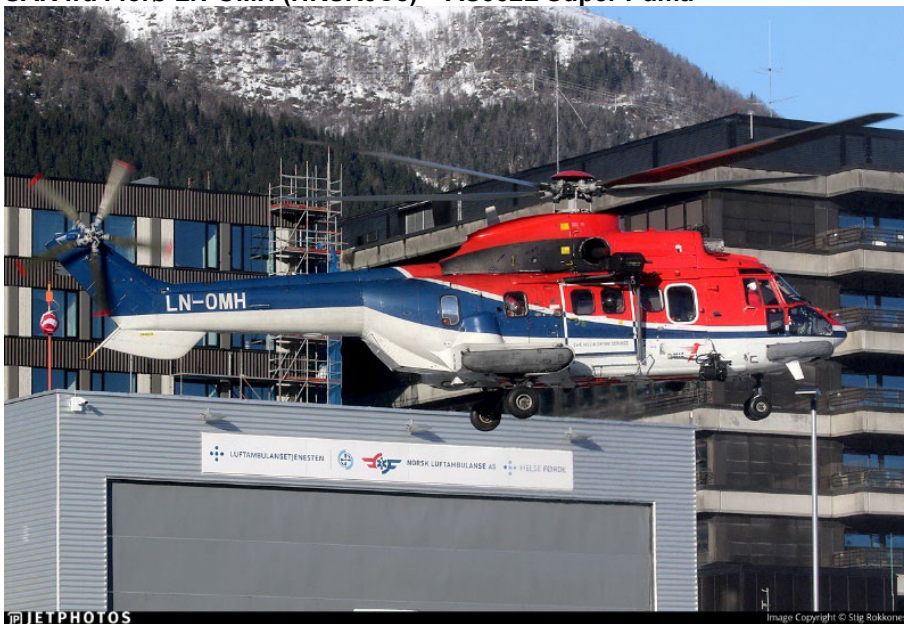
SAR fra Florø LN-OMH (HKS5C8) – AS332L Super Puma

The Airbus Helicopters H215 helicopter, formerly called Eurocopter AS332 SuperPuma, with serial number 2113 was manufactured in 1984 by Aérospatiale, France. It is operated by CHC for the Rescue Helicopter Service.

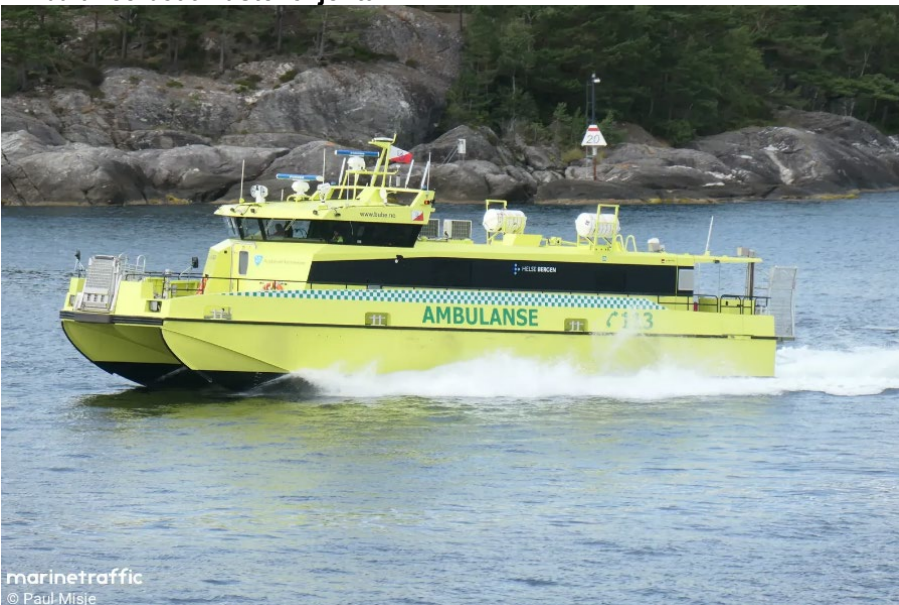
Ambulance boat Austevolljenta

Length 22.24 meters, width 7.5 meters.

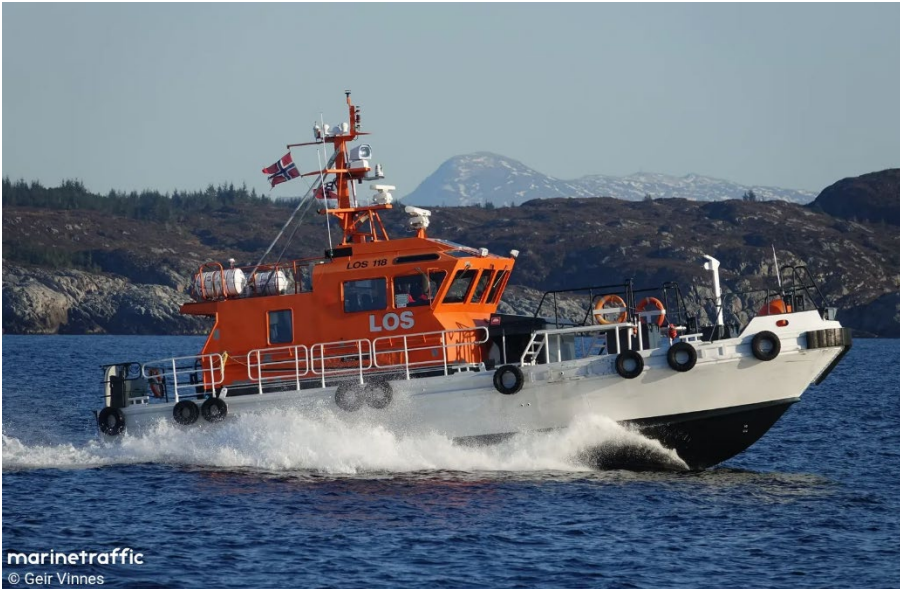
L/B «LOS 118»

Length 16.80 m, width 5.20 m, speed up to 29 knots.

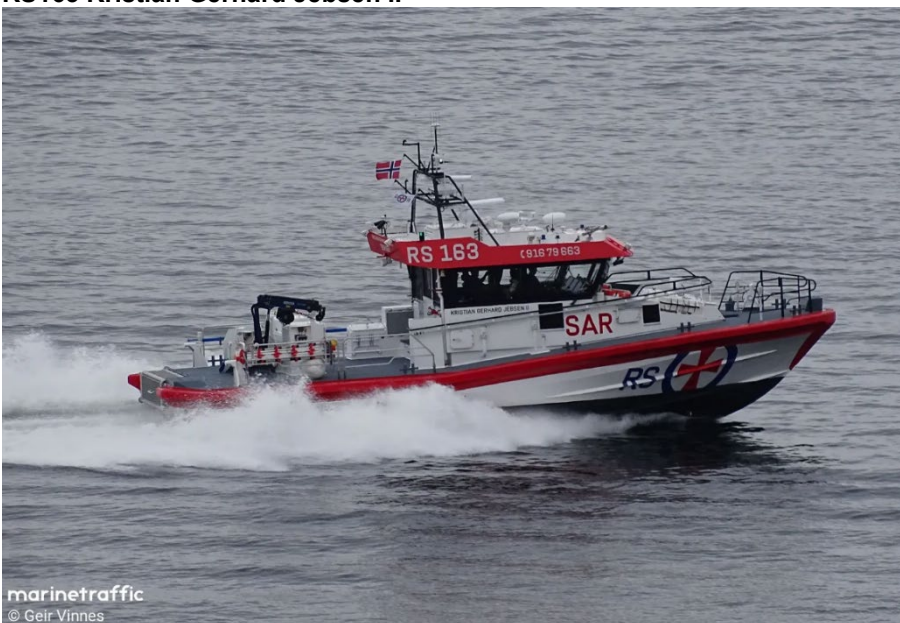
RS163 Kristian Gerhard Jebsen II

Length 17 m, width 4.6m, speed 42 knots

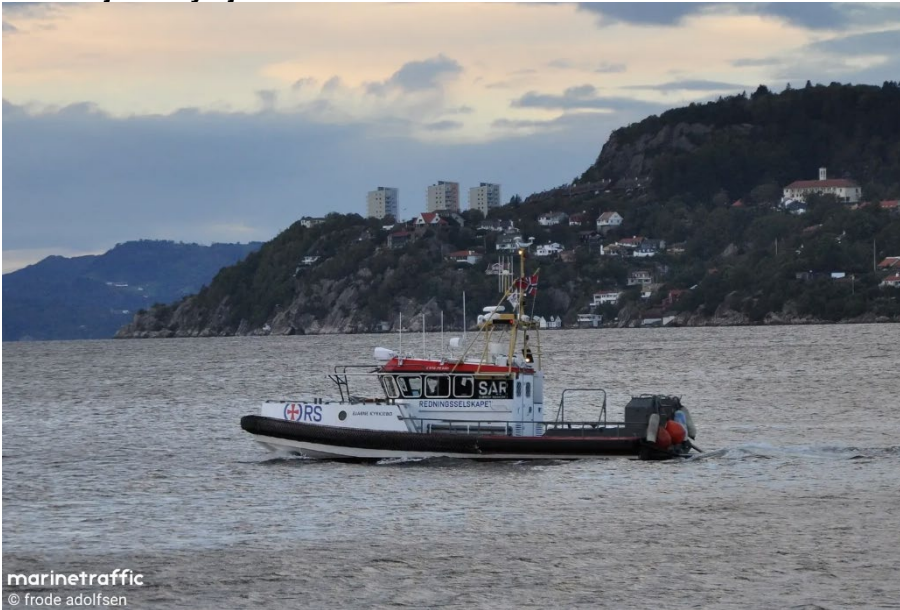
RS140 Bjarne Kyrkjebø

Length 12.75 m, width 3.48 m, speed 30 knots

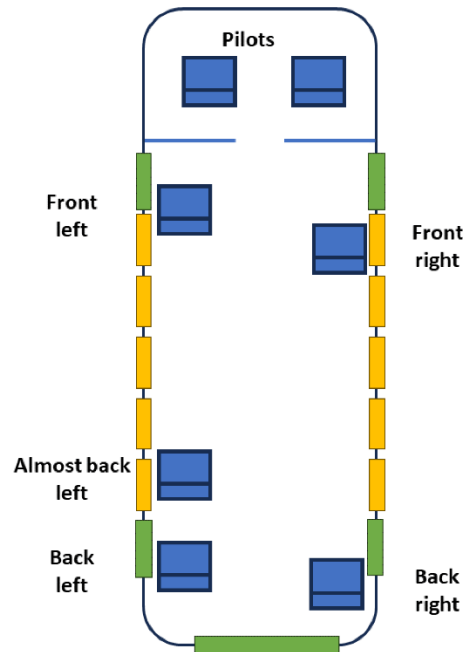
In the sketch on the right, the seats are shown in blue, primary emergency exits are shown in green, and windows are shown in orange

NB! The sketch is only intended as an illustration and does not have correct measurements!
